IMPORTANT UPDATE:
RESET & SOFTWARE UPDATE PROCEDURE
for Tesla Models 3/Y with Software Versions
2021.36.X and 2021.40.X

Vehicles: Tesla Model 3, Model Y (Does not apply to other makes/models)

Software Versions: 2021.36.x, 2021.40.x

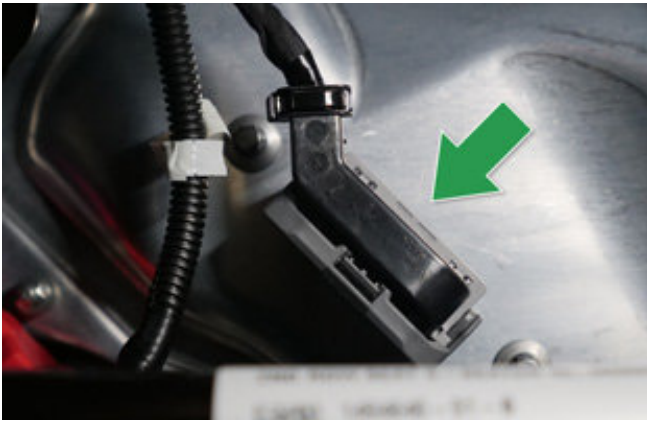
Model 3: Located under passenger side rear seat (to access, slide seat lock tab toward center driver side to unlatch, then lift seat cushion up, remove black foam block, and locate grey plug underneath)

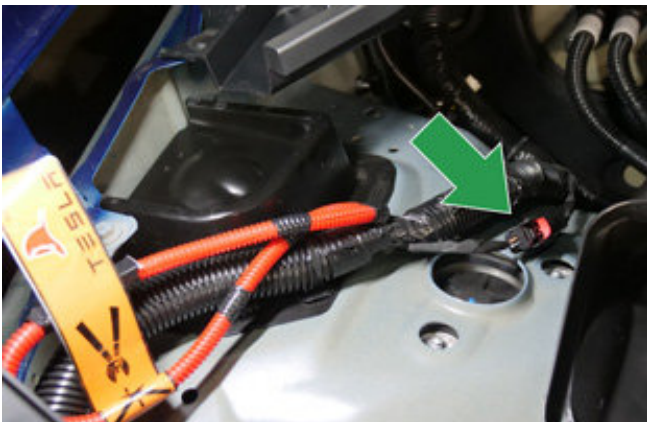
Model Y: Located in Frunk on passenger side above wheel well (red/black connector near First Responder Loop w/ orange tag)
