Liftgate Water Ingress at Hinges

Classification Repair Bulletin **Section/Group** 11 - Closures **Country/Region** All

Year All **Model** Model S **Version** All

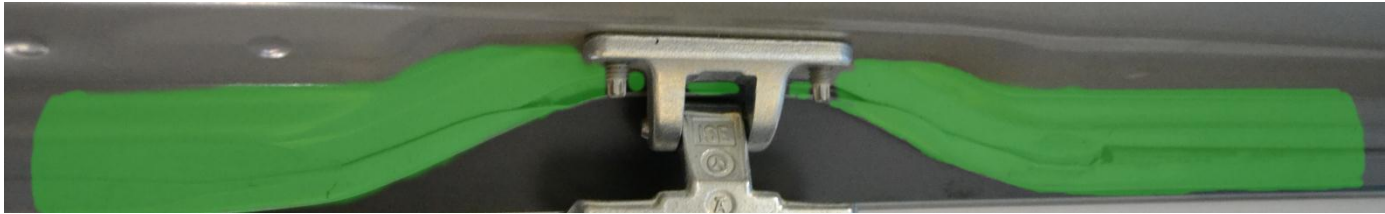
Figure 1 (LH shown, RH similar)

Water ingress might occur if the vehicle is exposed to moderate rainfall for many hours. Water might enter the liftgate at the hem edge near the hinges. This may result in water retention in the liftgate shell, leading to potential corrosion of GPS or radio antenna electrical connections, causing poor reception for those features.

3. Clean the highlighted surfaces with an alcohol wipe to ensure proper adhesion of the sealer (Figure 1). Clean behind both liftgate hinges.
