Tesla, Inc. Service Bulletin		Adjust Overflush Charge Port Door	
SB-20-10-001 June 9, 2020			
Classification		Section/Group	Mobile Service
Repair Bulletin		10 - Body	Can Perform (where permitted)
Model Year	Model	Country/Region	Version
All	Model 3, Model Y	All	All
The model(s) and model year(s) listed are a general approximation of the affected VIN list. Refer to the VIN/Bulletin Tracker or Customer/Vehicle profile to determine applicability of this bulletin for a particular vehicle.

Some Model 3 and Model Y vehicles might have a charge port door that is overflush (protrudes in comparison) to the LH taillight assembly.

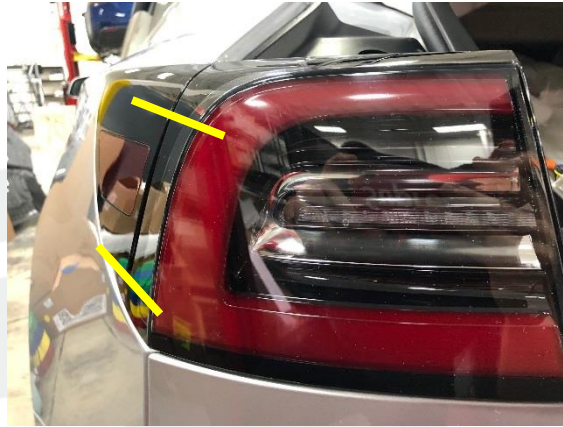
Figure 1 – Overflush check locations

NOTE: Record the overflush at the top and bottom (Figure 1) of the line between the charge port door and the LH taillight. Overflush in the middle is not considered, as it is not adjustable.

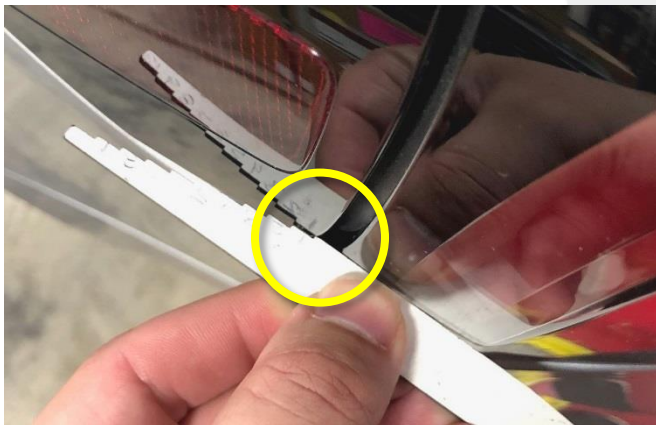
2. If the overflush at:
 - Both the top and bottom is 1.5 mm or less (Figure 2), the overflush is within specification. Discontinue this procedure.
 - Either the top or bottom is greater than 1.5 mm (Figure 3), continue to the next step.

✓ **Figure 2 – Overflush 1.5 mm or less**

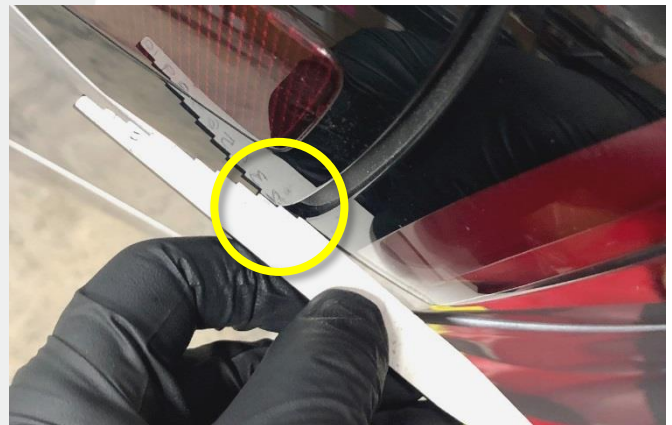
✗ **Figure 3 – Overflush greater than 1.5 mm**

7. Use the PDR charge port knockdown kit (if available) or a dead blow hammer and HV battery handle to adjust the sheet metal where the overflush is greater than 1.5 mm.
