Tesla, Inc. Service Bulletin		<i>Replace 2nd Row Seat Back Panels</i>
SB-20-13-003 April 9, 2020				
Classification		Section/Group		
Campaign Bulletin		13 - Seats		Mobile Service
				Can Perform (where permitted)
Model Year	Model	Country/Region		Version
2020	Model Y	North America		All
The model(s) and model year(s) listed are a general approximation of the affected VIN list. Refer to the VIN/Bulletin Tracker or Customer/Vehicle profile to determine applicability of this bulletin for a particular vehicle.

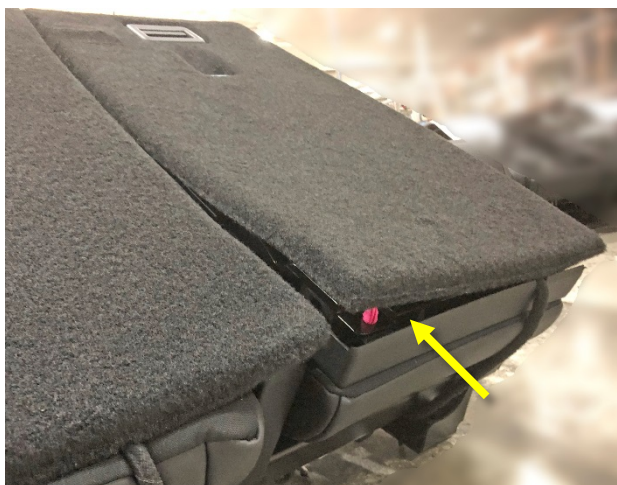
Certain Model Y vehicles might have been built with 2nd row seat back panels (left, center, and right) that did not meet internal specifications, resulting in the panels not being flush with the 2nd row seat.

✗ Figure 1 – Example of excessive gap between center seat back panel and seat

3. Replace all affected seat back panels:
 - **LH (60) 2nd row seat back panel:** Refer to Service Manual procedure [13082302](#).
 - **RH (40) 2nd row seat back panel:** Refer to Service Manual procedure [13082312](#).
 - **Center (20) 2nd row seat back panel:** Refer to Service Manual procedure [13082322](#).
4. Close the liftgate and both rear doors.

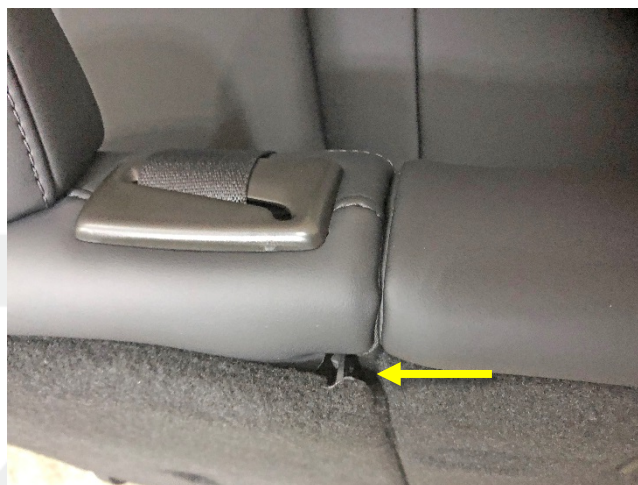
✗ Figure 2 – Example of excessive gap between LH seat back panel and seat
