Tesla, Inc. Service Bulletin		<i>Inspect Charge Port Busbar Safety Cap And Protective Earth Busbar</i>	
SB-20-44-002 July 24, 2020			
Classification		Section/Group	Mobile Service
Campaign Bulletin		44 - High Voltage System	Can Perform (where permitted)
Model Year	Model	Country/Region	Version
2020	Model Y	North America	All
<small>The model(s) and model year(s) listed are a general approximation of the affected VIN list. Refer to the VIN/Bulletin Tracker or Customer/Vehicle profile to determine applicability of this bulletin for a particular vehicle.</small>

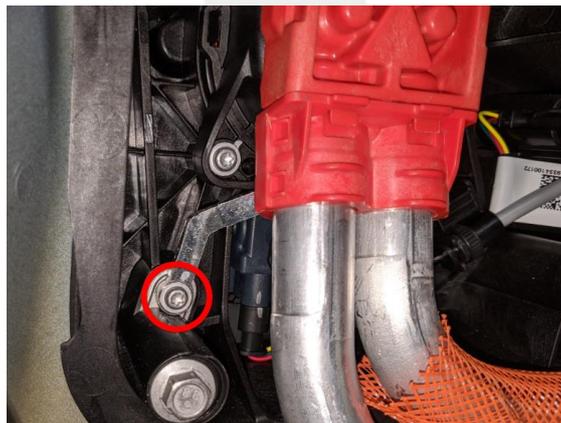
Figure 2

3. Remove the LH C-Pillar bracket (refer to Service Manual procedure [15186402](#)).
4. Perform a torque check on the screw that attaches the PE busbar to the charge port carrier (torque 3.0 Nm) (Figure 2).

- If the screw cannot be properly torqued, or if there is damage to the PE busbar/charge port bolt threads:
 - a. Replace the charge port (refer to Service Manual procedure [44011602](#)), but return to this procedure after performing the resistance test between the charge port busbar lead and charge port busbar stud.
 - b. Skip to step 11.
- If the screw can be properly torqued, and there is no damage to the PE busbar/charge port bolt threads, continue to step 5.

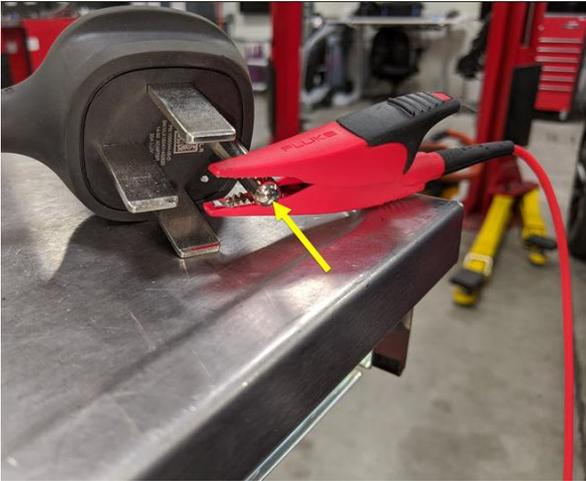
Figure 3

5. Connect the handle of a known working UMC (Universal Mobile Connector) with a NEMA adapter to the vehicle charge port. Do not plug the other end of the UMC into a wall outlet.
6. Set the multimeter to resistance measurement mode, and then using alligator clips, attach the multimeter to the UMC NEMA adapter ground pin (Figure 3) and charge port PE busbar (Figure 4).

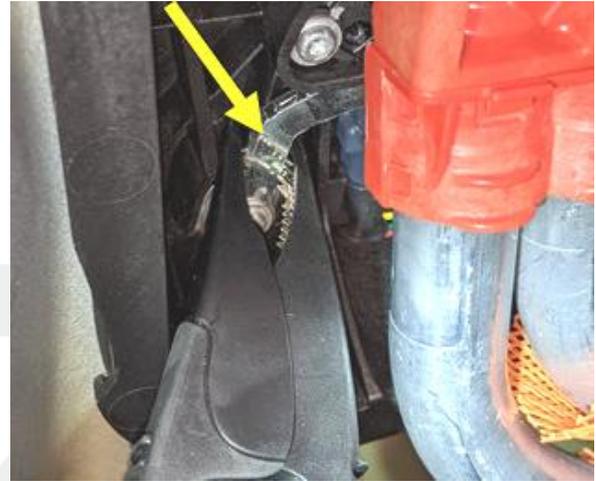
Figure 4

7. While monitoring the resistance reading on the multimeter, wiggle the UMC handle horizontally for 10 seconds, and then vertically for 10 seconds, making sure not to touch the release button on the handle.

- If while wiggling the UMC handle, the multimeter displays “OL” (Open Line) or fluctuates above 0.2 Ω :
 - a. Disconnect the alligator clips from the UMC and charge port PE busbar.

- b. Disconnect the UMC handle from the vehicle charge port.
 - c. Replace the charge port (refer to Service Manual procedure [44011602](#)), but return to this procedure after performing the resistance test between the charge port busbar lead and charge port busbar stud.

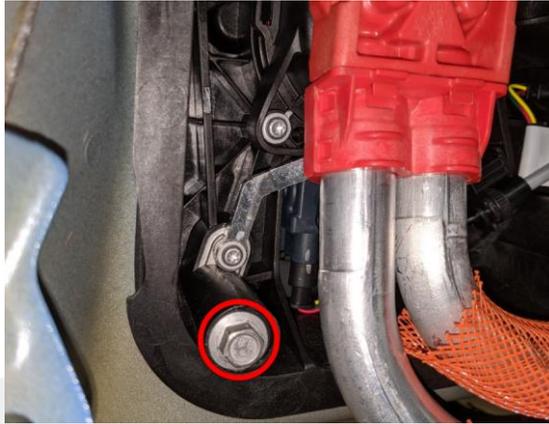
Figure 5

10. Perform a torque check on the bolt that attaches the charge port carrier ground to the body (torque 5.5 Nm) (Figure 5).

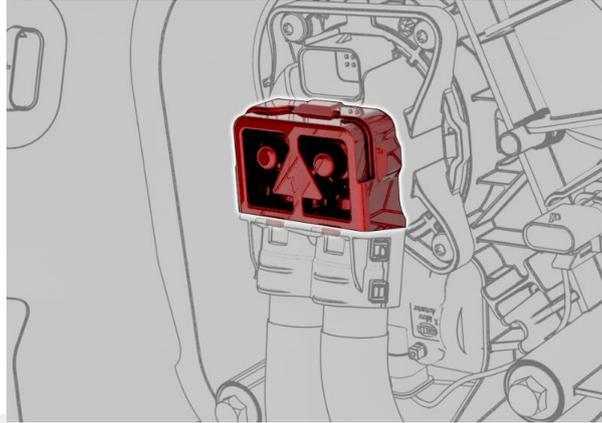
Figure 7

14. If not already removed, remove the charge port busbar safety cap from the vehicle (Figure 7).

16. Install the charge port busbar safety cap (Figure 7).

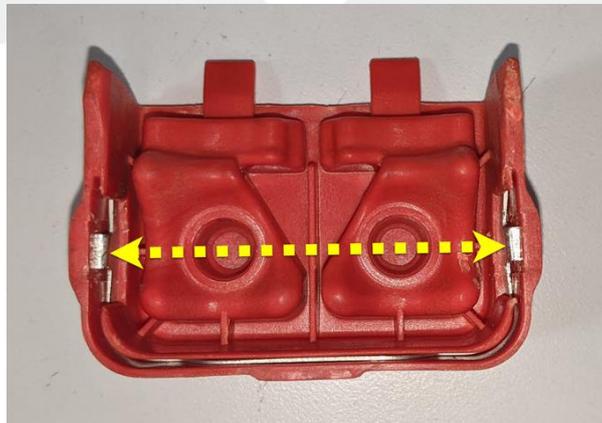
Figure 8

15. Using digital calipers, measure the distance between the electrical terminals on the underside of the charge port busbar safety cap (Figure 8).

- If the distance between the two terminals is less than 45.94 mm, remeasure the distance. If the measurement is still less than 45.94 mm, continue to step 16.
- If the distance between the two terminals is between 45.94 mm and 46.24 mm, continue to step 16.
- If the distance between the two terminals is greater than 46.24 mm:
 - a. Use needle nose pliers and a pocket screwdriver to equally bend both terminals toward the center of the charge port busbar safety cap.
 - b. Remeasure the distance between the terminals and continue to step 16 when the measured distance is between 45.94 mm and 46.24 mm.

**NOTE:** If the terminals are damaged, or if unable to properly rework the terminals, procure a new charge port busbar safety cap, and then continue to the step 16.
