Service Bulletin

Number	SVC-09-10-007
Author	Service Operations
Date	15-Feb-10 - Update
Model & Year	Roadster, 2008/2010

Title: EV Light Ring De-Bond Repair

Reason: Repairing de-bonded light rings on body side panel

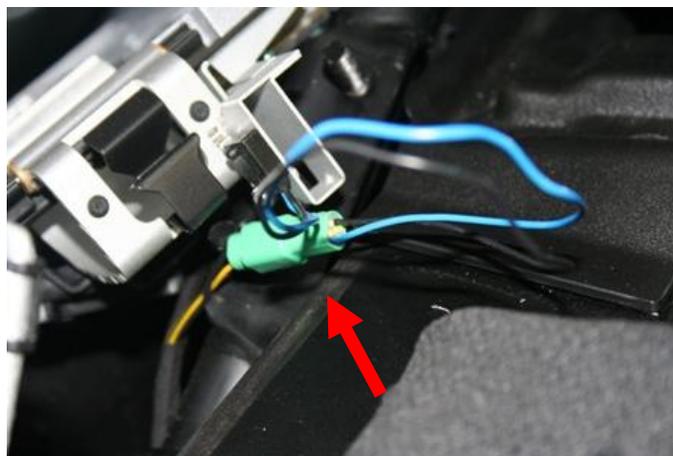
Caution: Use care when removing the green charge door connector. The wires can separate very easily and become damaged.

6. Apply light pressure and separate the charge port ring from the body side panel.
7. Disconnect the LED connector and the charge door switch connector.
