TN-22-16-001 June 8, 2022

Tesla, Inc. Technical Note
Model:	Vehicle System:	Region:
Model Y Structural Pack	16 - Battery System	All

Inspect the Model Y Structural HV Battery for Underside Damage

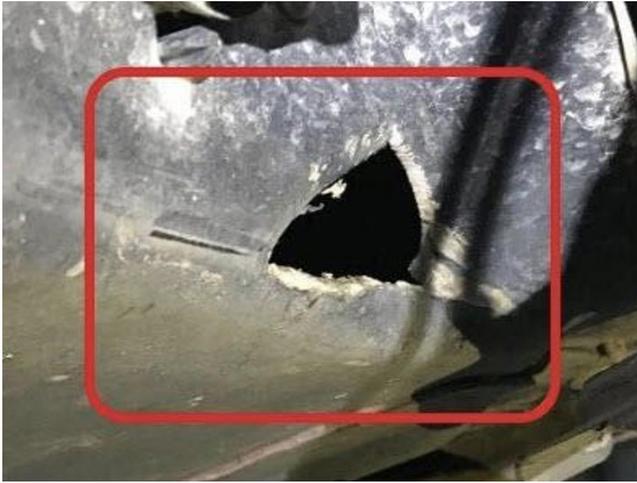
⚠ WARNING: If the HV battery enclosure is compromised with a **visible open hole, crack, or tear** (Figures 2 and 3), the Service Center doesn't need to continue further with this document and should recommend the customer replace the HV battery to meet Tesla's standards of quality and safety. Meanwhile, the HV battery might be compromised and needs to be taken care of diligently; refer to Toolbox article [29715](#) for assessing a compromised HV battery.

Figure 2 – Visible open hole

☰ NOTE: If at any point during the inspection the damage requires a HV battery replacement, advise the customer that the HV battery requires replacement to meet Tesla's standards of quality and safety. Tesla does not recommend driving the vehicle until the HV battery is replaced. Since the new HV battery replacement is not covered under the vehicle warranty, the Service Center should recommend that the customer replace the HV battery and provide the customer a price quote for the HV battery replacement. The warranty does not cover HV battery damage caused by an external impact.

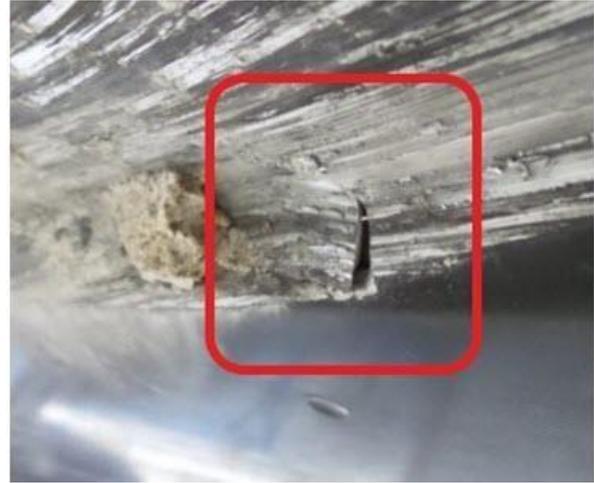
Figure 3 – Visible open crack

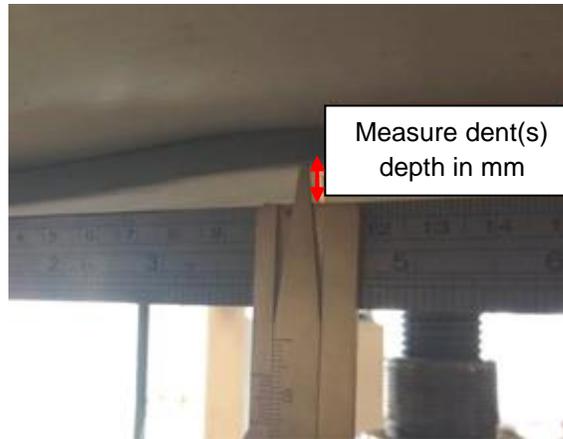
Figure 8 – Measuring the depth of enclosure damage

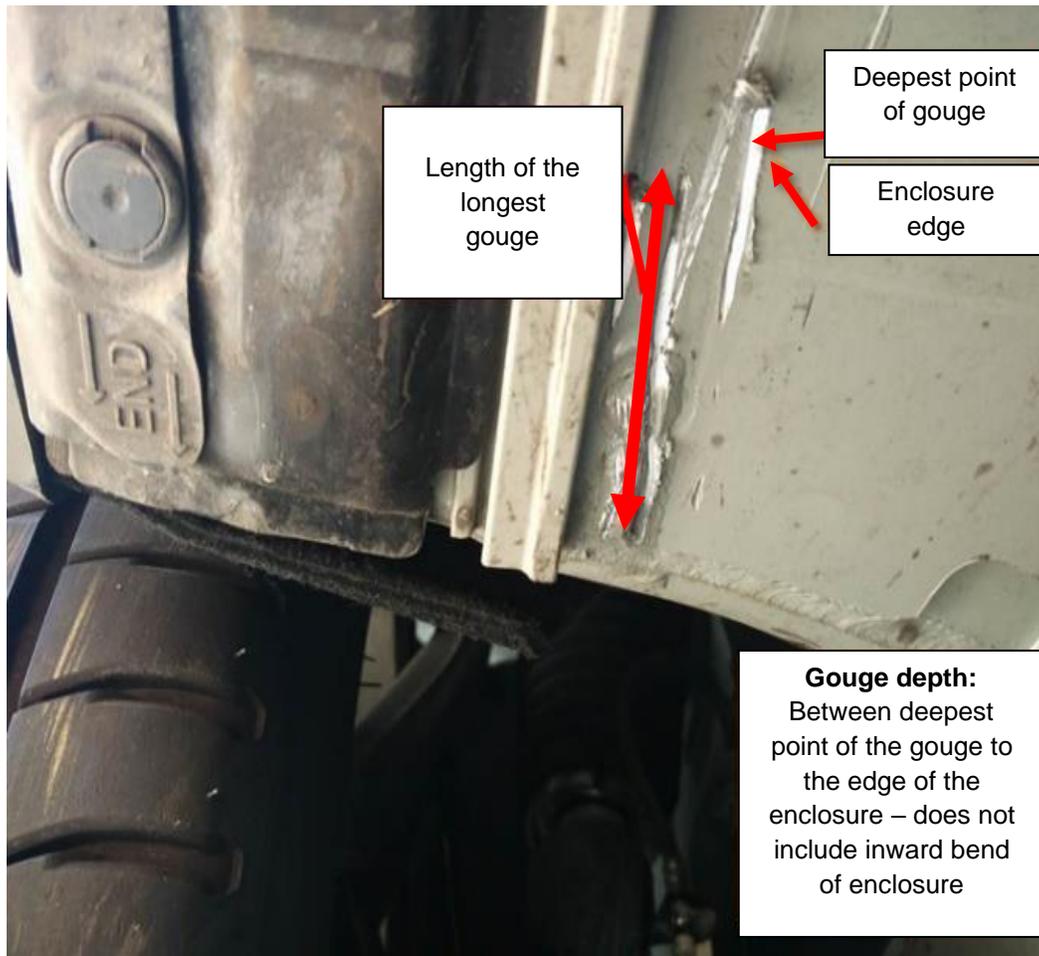
- Deburr the area with a hand deburring tool to remove the sharp edges if sharp edges are found.
- Recommend HV battery replacement if:
 - A dent or deepest point of gouge is **5 mm** or more in depth (Figures 17 and 18) within the array baseplate zone.

NOTE: Depth measurements should only be taken within the baseplate zones, **NOT** the array barrier zone. If a dent overlaps into an array barrier zone, measure the largest depth within just the baseplate zone, even though the deepest depth may be within the array barrier zone.

Figure 17 – Gouges in the baseplate

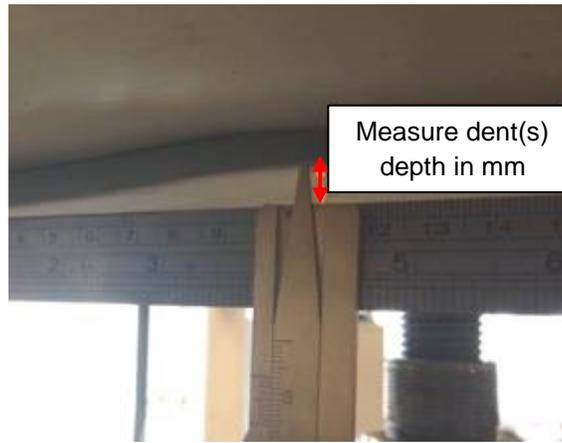
Figure 18 – Dents in the baseplate
