Tesla Roadster GPS Firmware Update Notes

v1.0 18/6/20

Overview

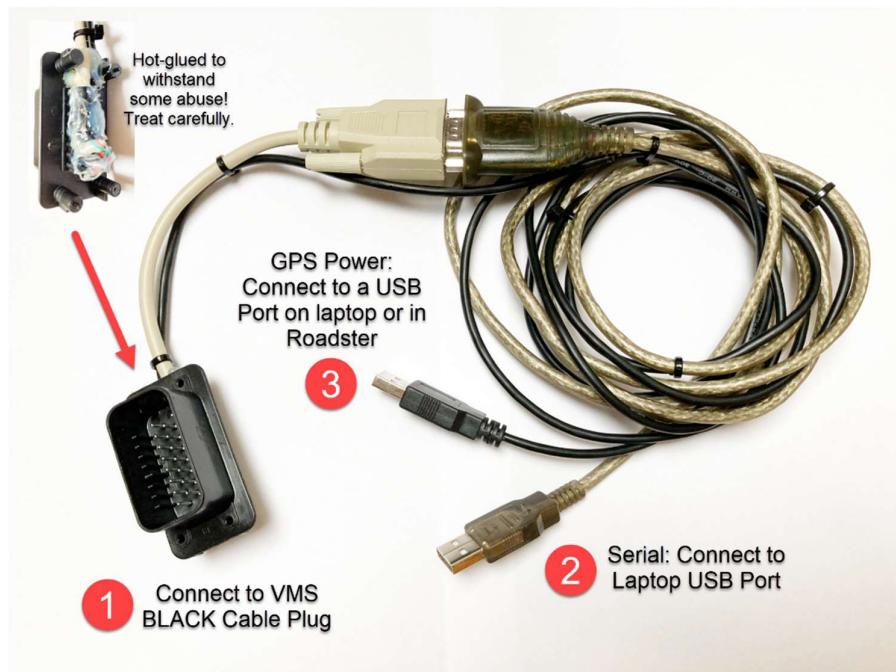
The cable is based on an ATEN USB-Serial adapter I had in my workshop. As I did not fancy removing a moulded connector (done that too many times in the past!), I have taken a different (less hardy) approach than Steve, using a 9-way D socket together with an additional USB cable for power.

I have not put it all in an enclosure. Instead everything is hot-glued on the main plug. It should be rugged enough if you treat it gently!
