Tilt Screen Retrofit for 2021+ Tesla Model S

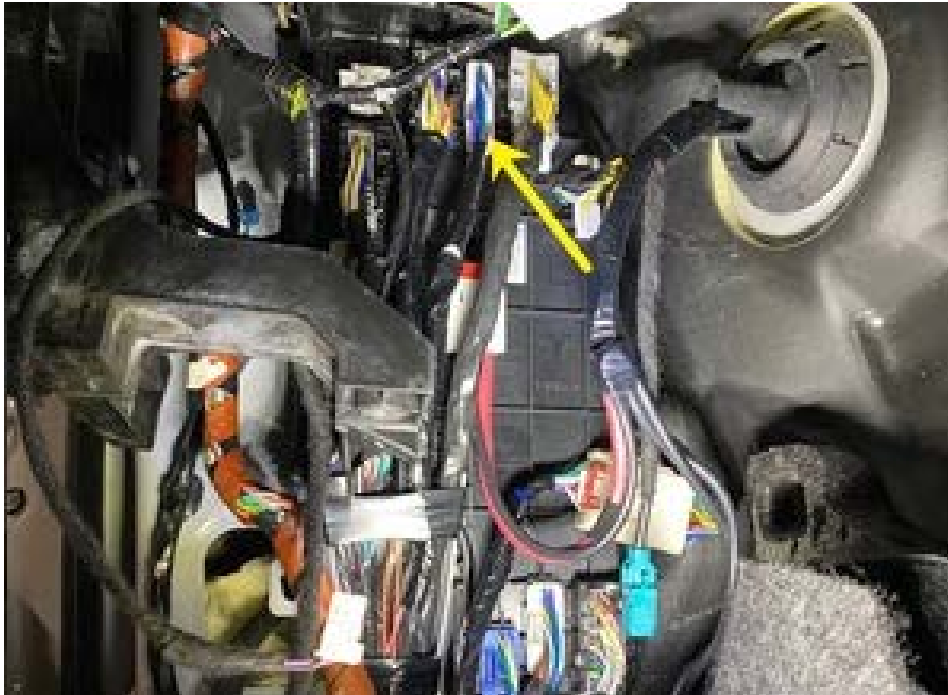
i.e. In the picture below the yellow arrow points to connector (J4) with standard push tab in the middle of either side, however; the black connector on the left (J6/J7) and white connector on the right (J1/J2) have a similarly small/thin push lock along the long edge that must be pressed in while simultaneously pulling back the top of the connector in a half-circle motion to completely remove. J1/J2 lock tab is on the far-side, while the J6/J7 lock tab is on the near-side of you.

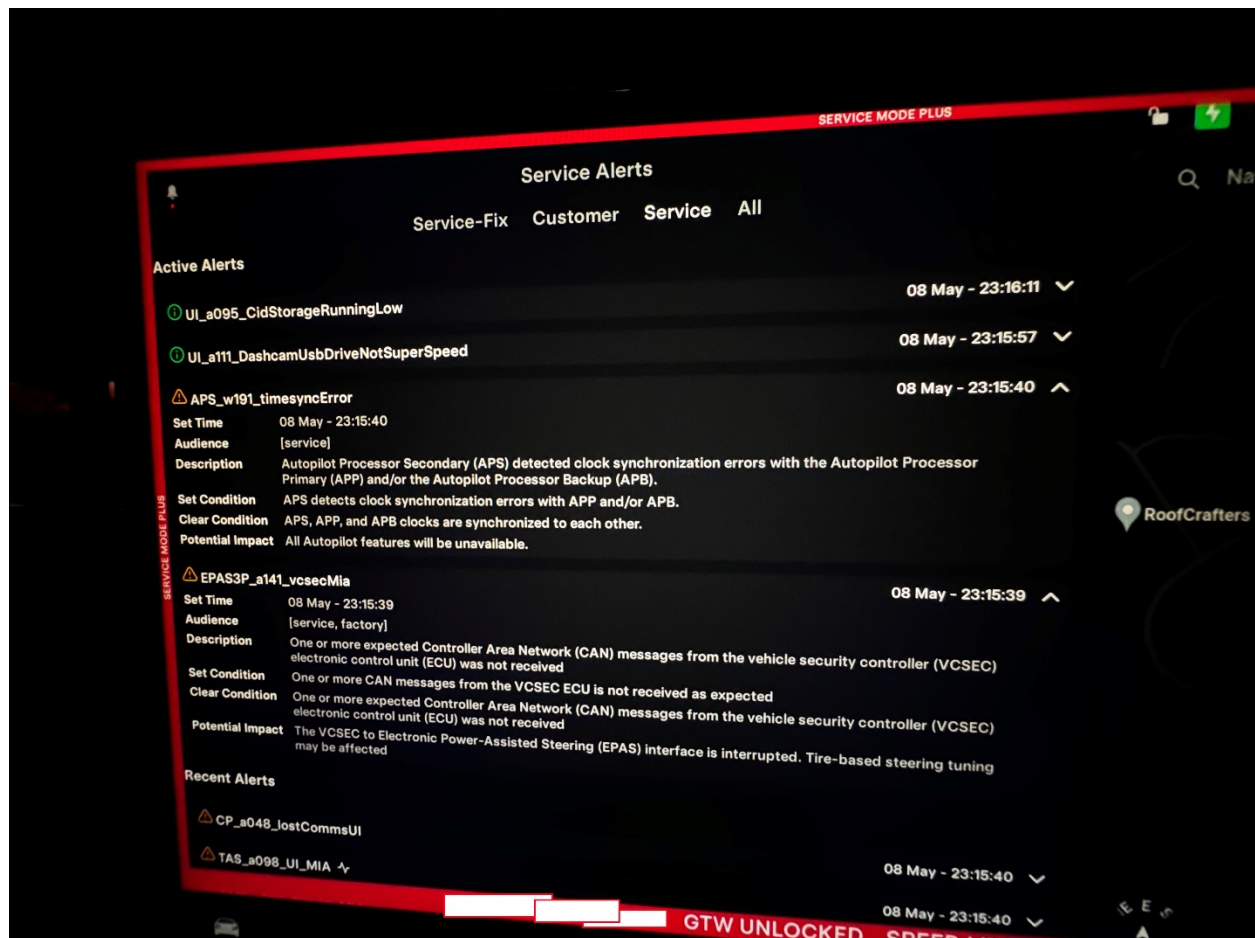
I had a few errors after it was completed (see pic below) but that cleared the next day after getting on Youtube and doing a double-wheel reset. So don't stress it too much.
