Tesla, Inc. Service Bulletin		<h2>Replace Front Drive Unit Halfshafts</h2>	
SB-21-39-001 R1 September 21, 2021			
Classification Repair Bulletin		Section/Group 39 - Front Drive Unit	Mobile Service Cannot Perform
Model Year 2014 - 2020	Model Model S, Model X	Country/Region All	Version All
<small>The model(s) and model year(s) listed are a general approximation of the affected VIN list. Refer to the VIN/Bulletin Tracker or Customer/Vehicle profile to determine applicability of this bulletin for a particular vehicle.</small>

Condition

Some versions of Model S and X front drive unit halfshafts might cause excessive vibrations during hard acceleration at higher ride height settings. This is exclusively an NVH issue and does not otherwise affect steering functionality, braking, or acceleration.

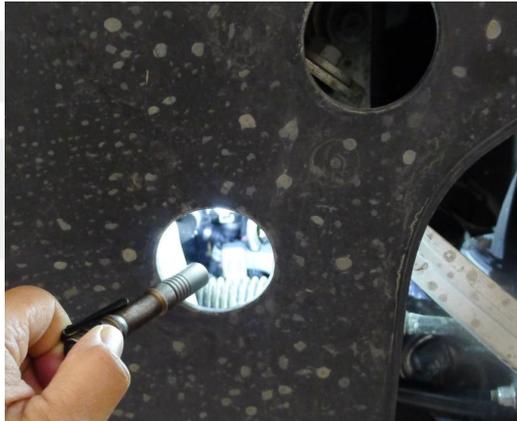
Figure 1

1. Raise and support the vehicle (refer to Service Manual procedure 10000205; [Model S](#), [Model X](#)).
2. Shine a light into the front aero shield LH front caster adjustment opening (Figure 1) and inspect the flanges of the front drive unit clevis that attach to the side rail.
 - If the clevis flanges are squared and fastened with hex bolts (Figure 2), clevis and halfshaft replacement are necessary; skip to step 3.
 - If the clevis flanges are rounded and fastened with External Torx bolts with large washers that obscure the flange (Figure 3), clevis replacement is not necessary; however, the halfshafts must be replaced. Skip to step 4.

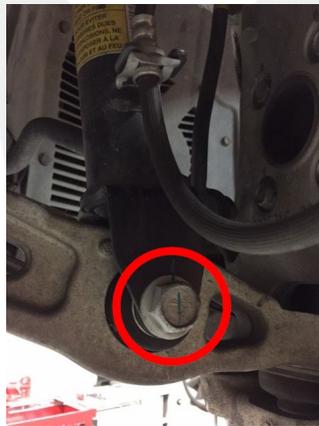
Figure 4 – LH shown; RH similar

13. Place the vehicle on a 4-post lift (refer to Service Manual procedure 10000405; [Model S](#), [Model X](#)).
14. Torque the nuts and bolts that attach the LH and RH front air spring modules to the front lower control arms (torque 140 Nm) (Figure 4).

15. Clean and mark the nuts with a paint pen.
16. Perform a ride height adjustment (refer to Service Manual procedure [31001100](#) (Model S), [31001000](#) (Model X)).
17. Remove the vehicle from the 4-post lift (refer to Service Manual procedure 10000405; [Model S](#), [Model X](#)).
18. Skip to section “Halfshaft Break-in and Test Drive” in this document.

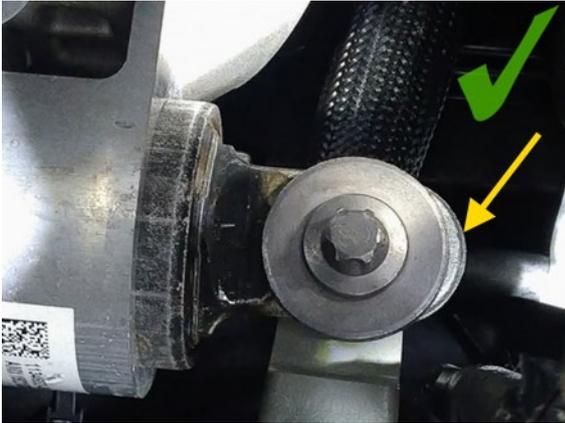
Figure 5

1. Remove the LH front drive unit halfshaft (refer to Service Manual procedure 39303102; [Model S](#), [Model X](#)).
2. **Vehicles built on April 25 or April 26, 2019:**
 - a. Inspect the foremost mounting bolt on the front drive unit clevis.
 - If the clevis is visible past the front edge of the foremost washer (Figure 5), the clevis does not require repositioning; skip to step 3.
 - If the clevis is not visible past the front edge of the foremost washer (Figure 6), the clevis requires repositioning; continue to step 2.b.

- c. Position a prybar between the clevis and body (Figure 8), and then pry the clevis towards the front of the vehicle until the clevis is visible past the front edge of the foremost washer (Figure 5).

**NOTE:** Make sure the clevis remains visible past the front edge of the foremost washer (Figure 5).

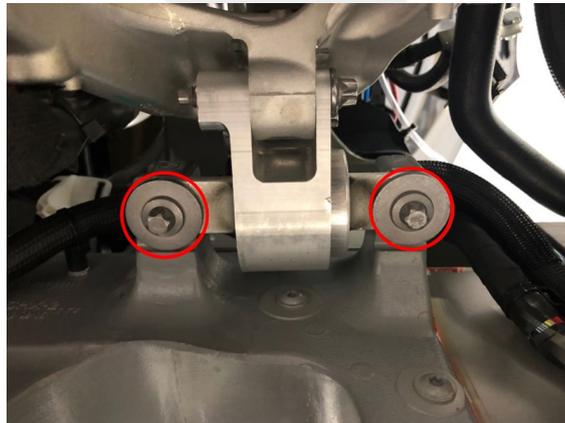
Figure 7

- b. Loosen, but do not remove, the bolts that attach the front drive unit clevis to the body (Figure 7).

d. Torque the bolts that attach the clevis to the body (torque 65 Nm) (Figure 7).

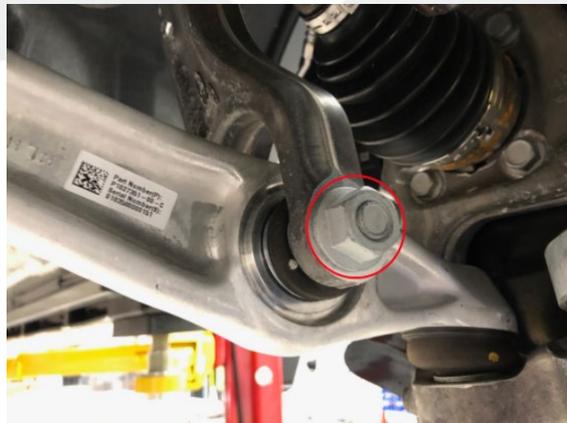
Figure 9 – LH shown; RH similar

3. Remove the RH front drive unit halfshaft (refer to Service Manual procedure 39303202; [Model S](#), [Model X](#)).
4. Install the LH front drive unit halfshaft, all LH suspension components, all LH brake components, and then return to this procedure (refer to Service Manual procedure 39303102; [Model S](#), [Model X](#)).
5. Install the RH front drive unit halfshaft, all RH suspension components, all RH brake components, and then return to this procedure (refer to Service Manual procedure 39303202; [Model S](#), [Model X](#)).
6. Install all other components that were removed for access.
7. Place the vehicle on a 4-post lift (refer to Service Manual procedure 10000405; [Model S](#), [Model X](#)).
8. Torque the nuts and bolts that attach the LH and RH front air spring modules to the front lower control arms (torque 140 Nm) (Figure 9).

9. Clean and mark the nuts with a paint pen.
10. Perform a ride height adjustment (refer to Service Manual procedure [31001100](#) (Model S), [31001000](#) (Model X)).
11. Remove the vehicle from the 4-post lift (refer to Service Manual procedure 10000405; [Model S](#), [Model X](#)).
12. Skip to section “Halfshaft Break-in and Test Drive” in this document.
