Trim - Liftgate Trough - Lower (Remove and Replace)

Correction Code 12271002

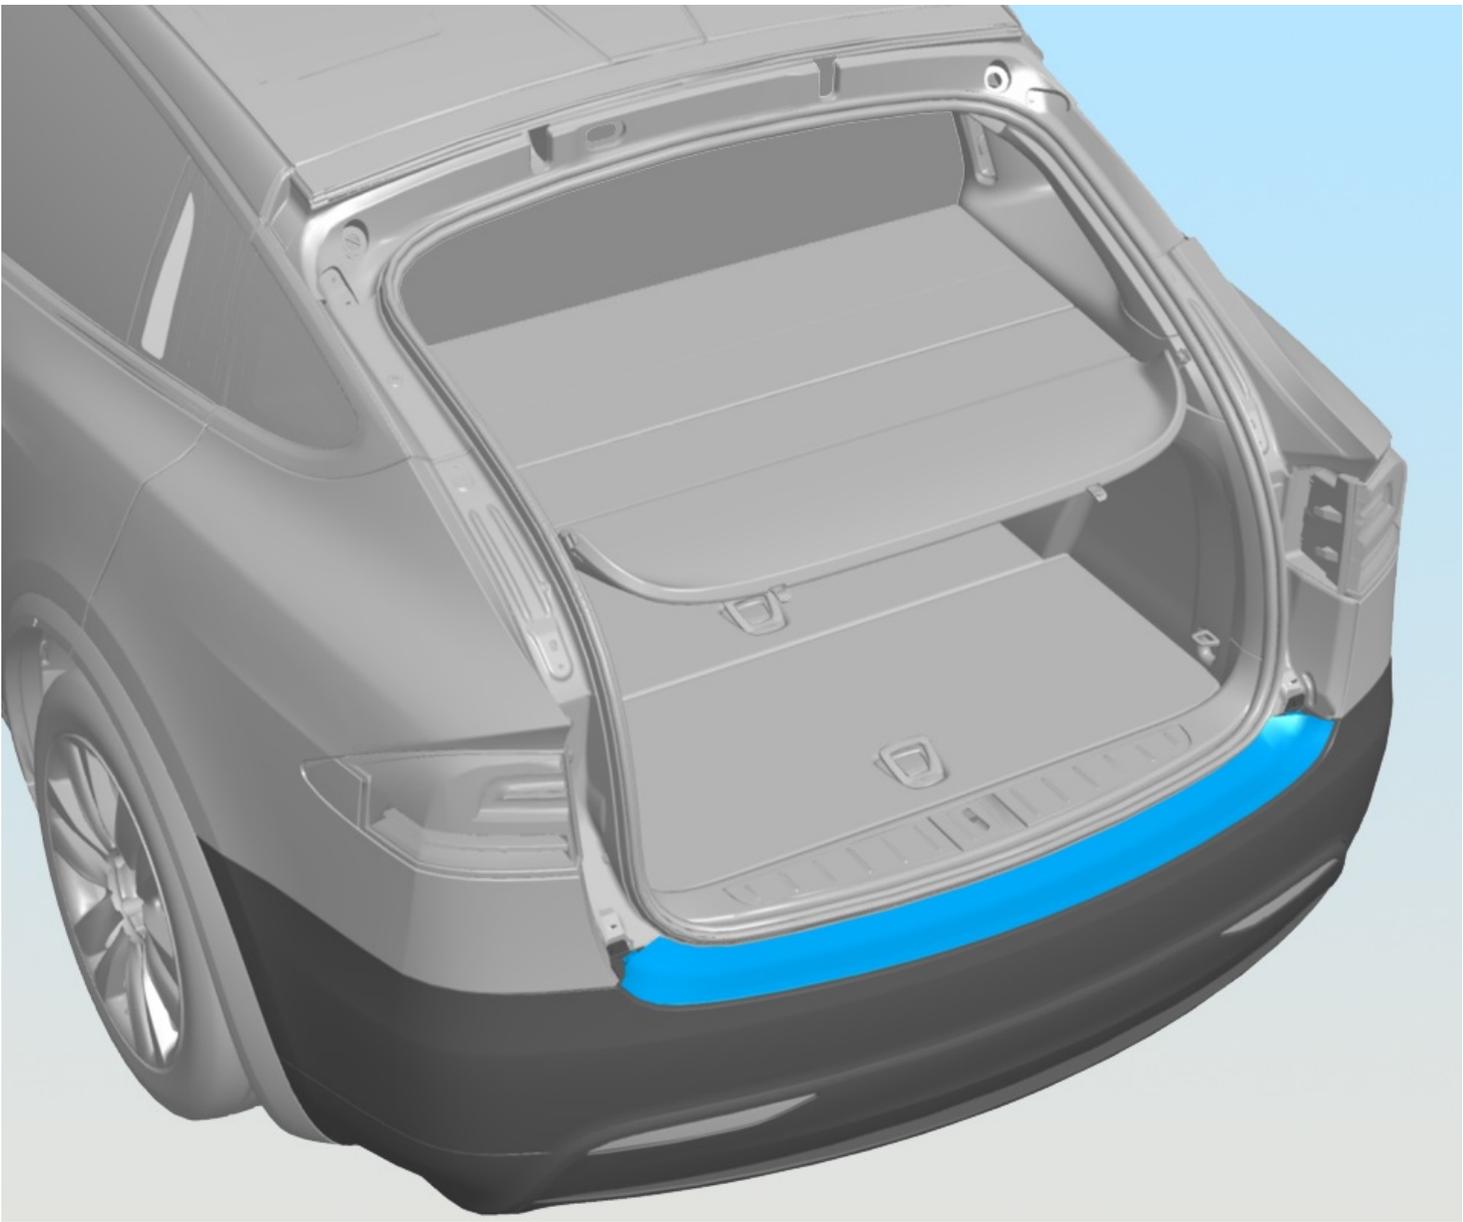
1. Open the liftgate.
2. Carefully release the lower portion of the liftgate seal.
3. Use a trim tool to release the lower liftgate trough trim.

Components have been removed in this graphic to aid clarity.

4. Remove the lower liftgate trough trim from the vehicle.
