Halfshaft - Rear Drive Unit - LH (Lubricate at Hub)

Correction Code 40302405

Repair

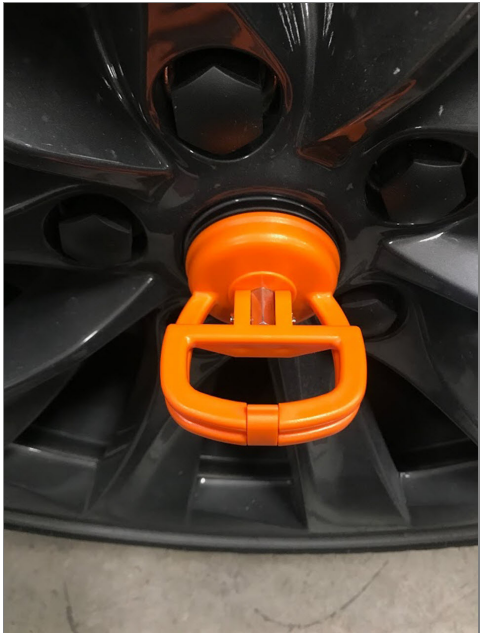
1.
- Use a suction cup clamp to remove the LH rear wheel center cap.

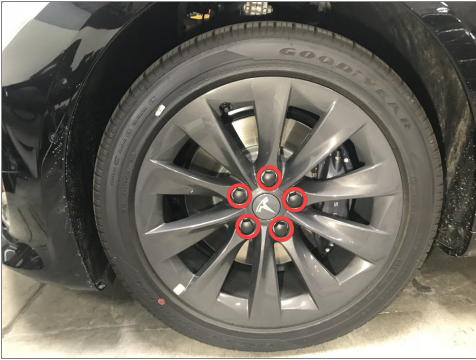
2. Use the wheel nut cover removal tool to remove the LH rear wheel lug nut covers.

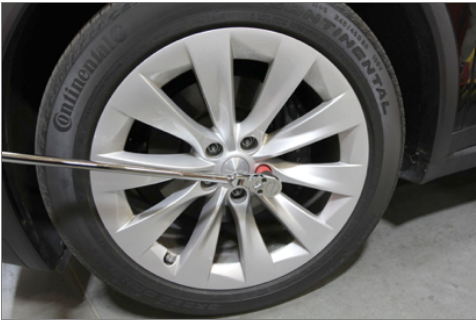
3. Loosen the LH rear wheel lug nuts.

CAUTION
Use only hand tools to remove or install the fasteners. Do not use impact or power tools.

CAUTION
Use a 6 point socket. Do not use a 12 point socket or a specialty socket.

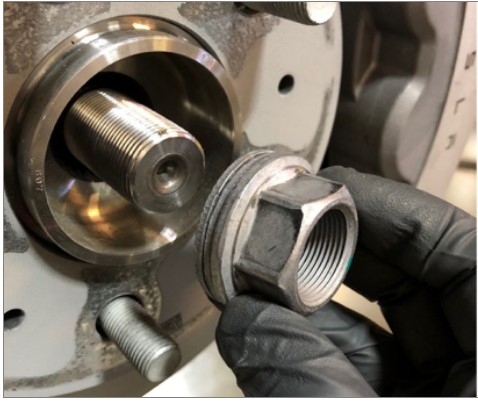
7. Remove and discard the LH rear drive unit halfshaft nut and washer.

Note
The washer is attached to the nut.

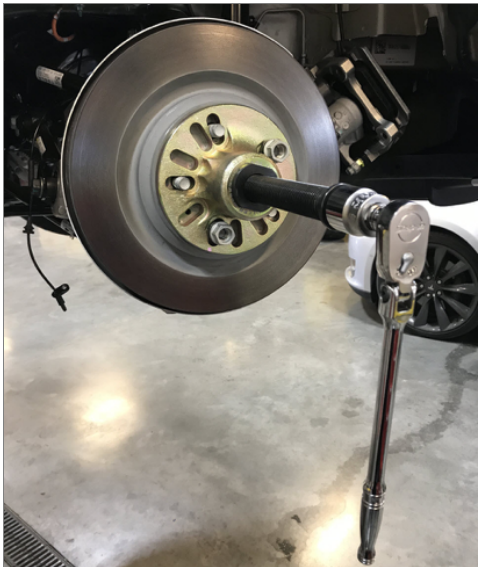
9. Hold the hub in position, and turn the hydraulic hub puller tool handle clockwise to push the LH rear drive unit halfshaft in from the LH rear hub assembly for a distance of 50 mm.

CAUTION
If the halfshaft stops moving in respect to the hub, stop, and turn the tool handle counter-clockwise for two turns.

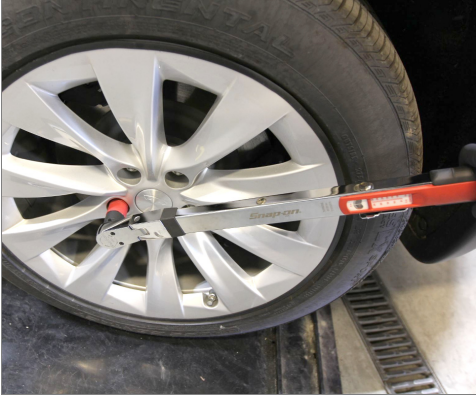
16. Fully tighten the LH rear wheel lug nuts in a star-pattern (torque 175 Nm).

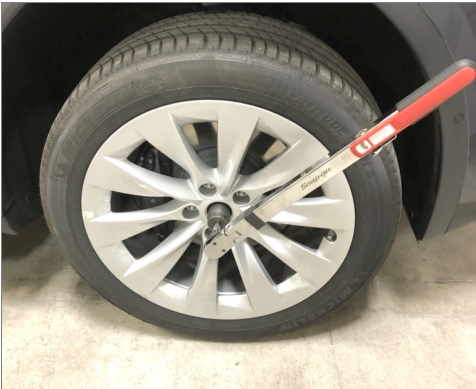
17. Fully tighten the LH rear drive unit halfshaft nut (torque 245 Nm).

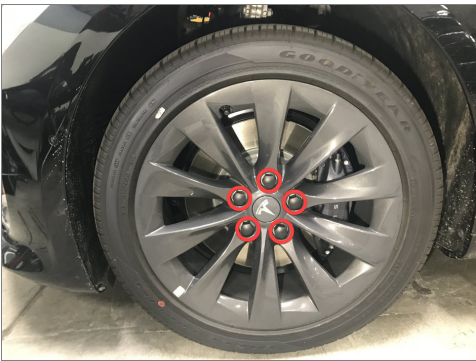
18. Install the LH rear wheel lug nut covers (x5).
