## HVAC Outlet Duct Upgrade

<b>Classification:</b>	Parts Bulletin	<b>Section/Group:</b>	18 - HVAC	<b>Country/Region:</b>	Global
<b>Year:</b>	All	<b>Model:</b>	Roadster	<b>Version:</b>	All

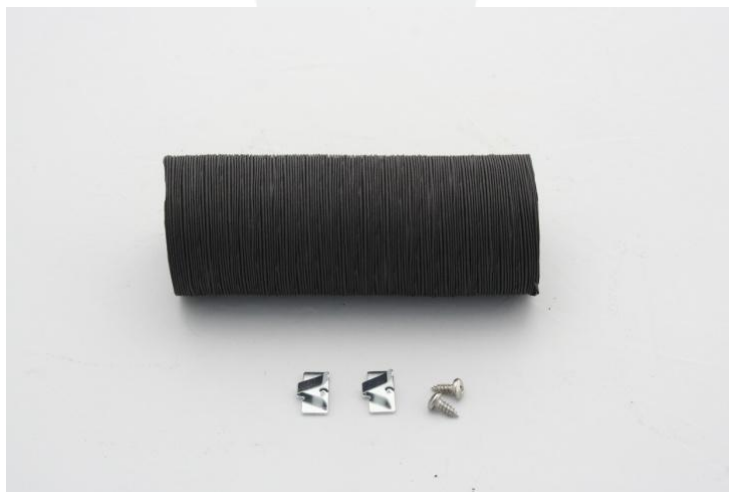
Figure 1

The Roadster Dual Heater Cooling Outlet Kit includes a pre-cut dual heater/cooling outlet tube, 2 screws, and 2 self adhesive mounting clips (Figure 1).
