Tesla, Inc. Service Bulletin		<i>Install Occupant Classification System (OCS) Filter Module</i>	
SB-19-20-003 R1 April 28, 2020		R1	
Classification Repair Bulletin		Section/Group 20 - Safety and Restraint	Mobile Service Can Perform (where permitted)
Model Year 2017-2020	Model Model 3, Model Y	Country/Region All	Version All
<small>The model(s) and model year(s) listed are a general approximation of the affected VIN list. Refer to the VIN/Bulletin Tracker or Customer/Vehicle profile to determine applicability of this bulletin for a particular vehicle.</small>

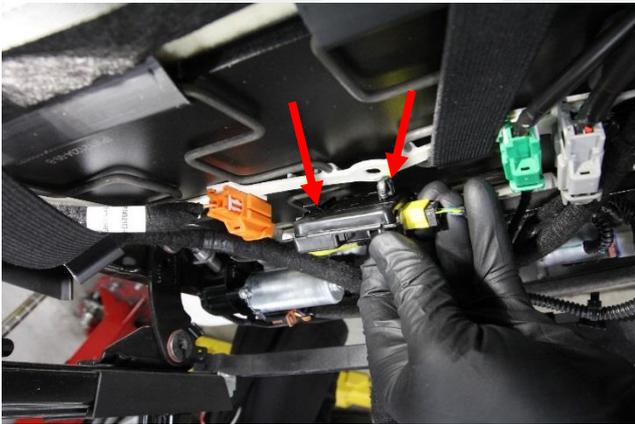
6. Attach the OCS filter module to the bottom of the seat and secure it with the clip (Figures 4 – 6).

TIP: Slide the tab of the OCS filter module over the white bar before securing the clip.

NOTE: Make sure the seat electrical harnesses are properly routed so that there is no tension in the cables.
