Tesla, Inc. Service Bulletin		<i>Inspect Front Fascia Injection Date</i>	
SB-20-10-003 July 9, 2020			
Classification		Section/Group	Mobile Service
Campaign Bulletin		10 - Body	Can Perform (where permitted)
Model Year	Model	Country/Region	Version
2020	Model Y	North America	All
<small>The model(s) and model year(s) listed are a general approximation of the affected VIN list. Refer to the VIN/Bulletin Tracker or Customer/Vehicle profile to determine applicability of this bulletin for a particular vehicle.</small>

On some Model Y vehicles, front fascias with an injection date in a certain date range might have potential delamination/peeling issues.

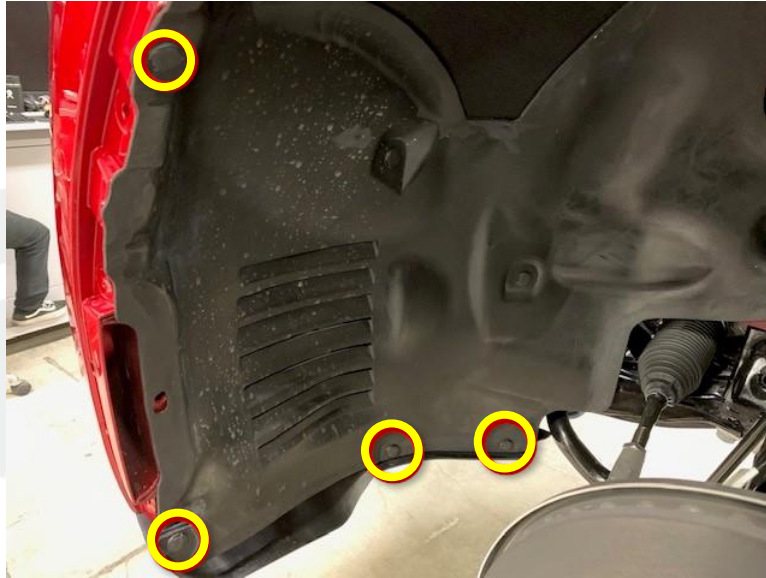
Figure 1 – Left front wheel removed for clarity

1. Open the LH front door.
2. Turn the steering wheel fully to the right.
3. Remove the LH front fender garnish (refer to Service Manual procedure [12201202](#)).
4. Remove the clips (x4) that attach the front of the LH wheel liner to the front fascia (Figure 1).

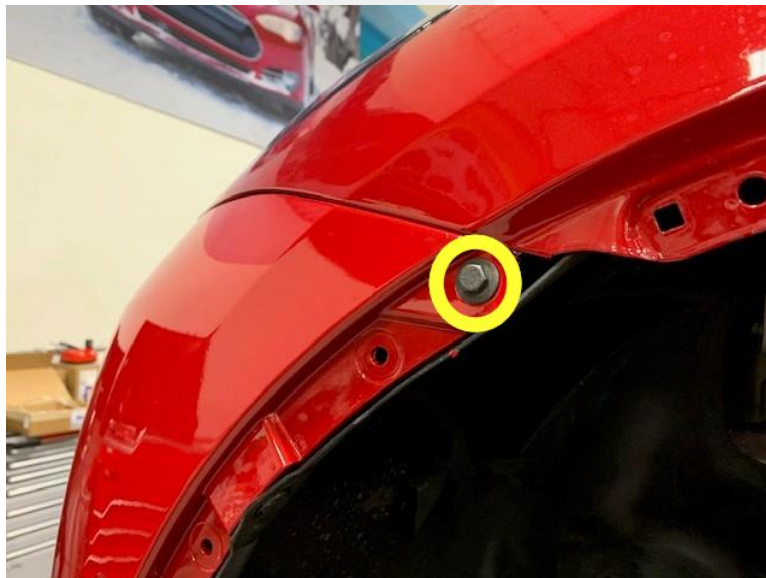
Figure 2

5. Remove the bolt that attaches the LH side of the front fascia to the fender (Figure 2).

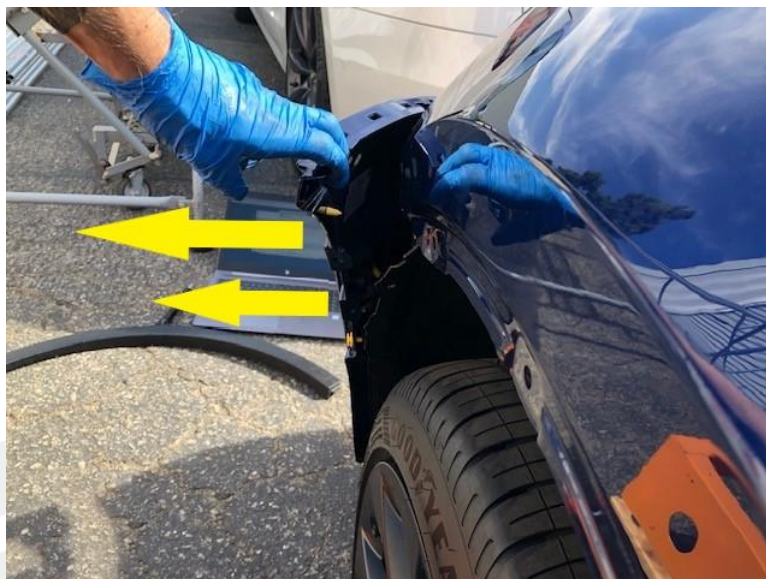
Figure 3

6. Carefully pull the LH side of the front fascia away from the LH fender (Figure 3).

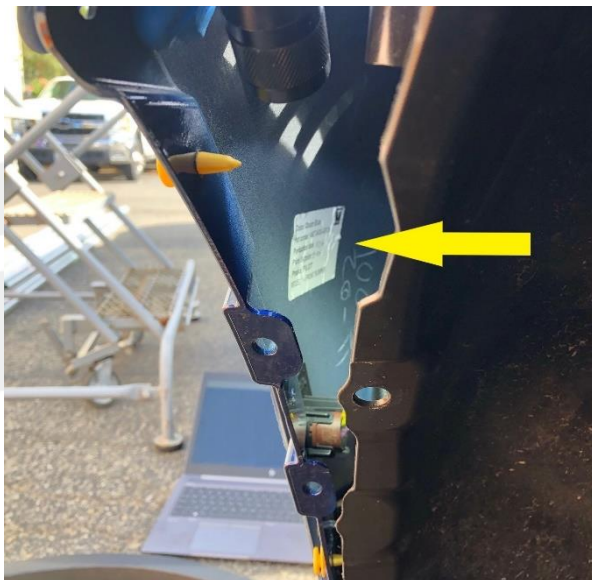
Figure 4

7. Inspect the injection date on the traceability label on the front fascia (Figure 4 and Figure 5).

**NOTE:** The “Date & Time” printed on the label is formatted as DD/MM/YYYY.

- If the “Date & Time” printed on the label is 22/02/2020 through 03/03/2020, replace the front fascia (refer to Service Manual procedure [10011002](#)).
- If the “Date & Time” printed on the label is before 22/02/2020 or after 03/03/2020, no repairs are needed. Install all parts that were removed for access, and then discontinue this procedure.
