<b>Tesla, Inc.</b> Service Bulletin		<h2>Reseal Liftgate Assembly to Prevent Water Ingress</h2>	
<b>SB-23-10-003</b> April 27, 2023		<b>R2</b>	
<b>Classification</b> Repair Bulletin		<b>Section/Group</b> 10 - Body	<b>Mobile Service</b> Can Perform (where permitted)
		<b>Configuration</b> All	
<b>Model Year</b> 2020 - 2023	<b>Model</b> Model Y	<b>Country/Region</b> All	<b>Build Location</b> Fremont, Giga Austin
<small>The model(s) and model year(s) listed are a general approximation of the affected VIN list. Refer to the VIN/Bulletin Tracker or Customer/Vehicle profile to determine applicability of this bulletin for a particular vehicle.</small>

On some Model Y vehicles, water may have leaked inside the rear trunk area through the liftgate assembly.

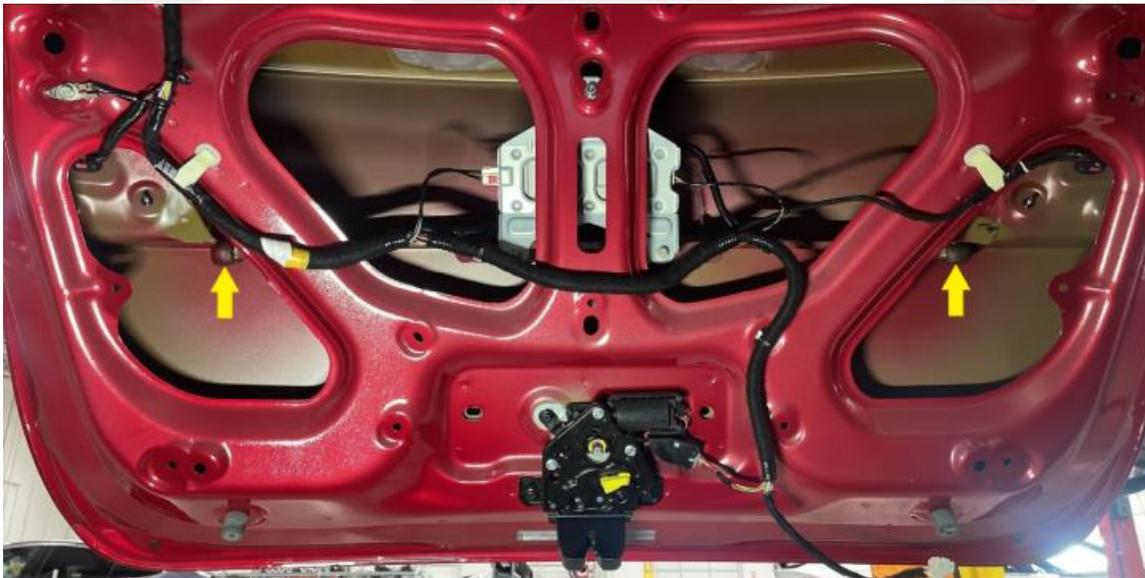
Figure 1

1. Remove the liftgate upper trim (refer to Service Manual procedure [15111002](#)).
2. Remove the liftgate lower trim (refer to Service Manual procedure [15111302](#)).
3. Remove the LH and RH rear fog/reverse lights (refer to Service Manual procedure [17402701](#)).
4. Remove and discard the factory foams (x2) (Figures 1–4) located under the LH and RH lamp can panels inside the liftgate assembly.

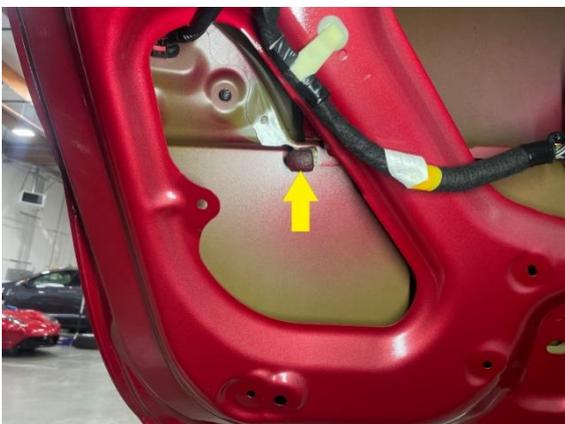
Figure 2 – LH factory foam inside liftgate assembly;  
RH similar

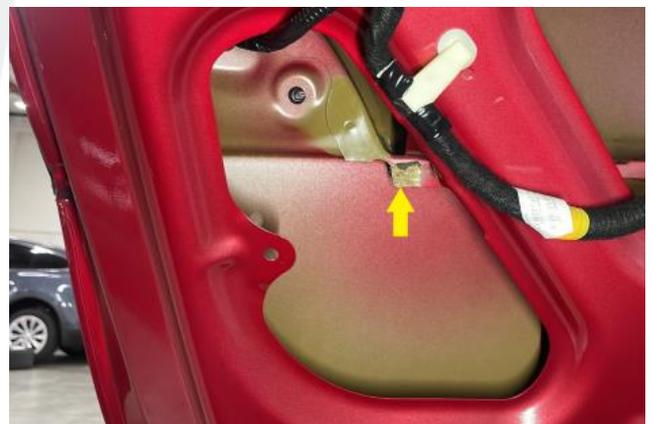
Figure 3 – LH factory foam removed from the liftgate  
assembly; RH similar

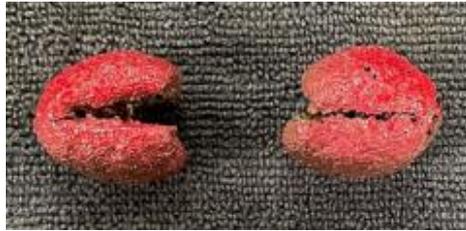
**Figure 4 – Detailed view of a factory foams removed from the liftgate assembly**

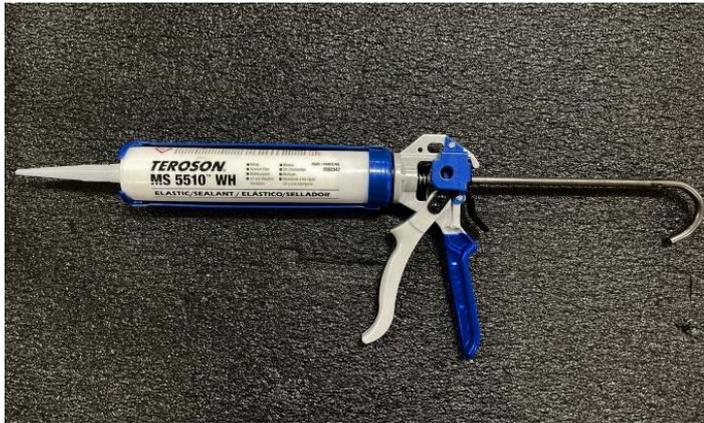
**Figure 5**

5. Prepare the caulking gun (1939249-00-A) with the 5510 white sealant (1939248-00-A) (Figure 5). Cut an approximately 4 mm wide opening on the sealant dispensing tube (Figure 6) using a retractable blade knife.

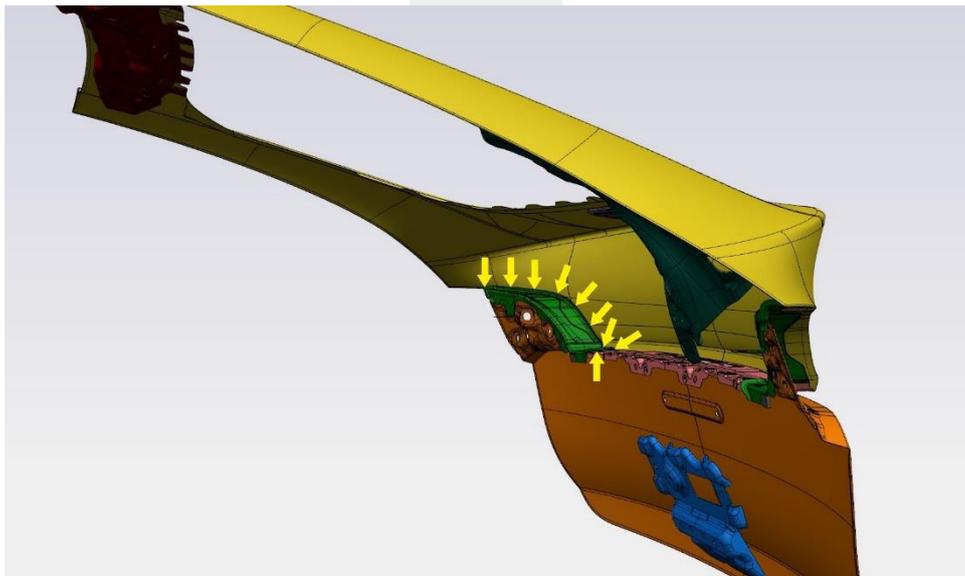
**Figure 7 – RH lamp can panel shown, LH similar**

6. Apply the sealant on top of the LH and RH lamp can panels located inside the liftgate assembly (Figures 7–10), and then spread the sealant bead with your finger (Figures 11 and 12) while wearing a nitrile glove. Apply several sealant beads as needed.

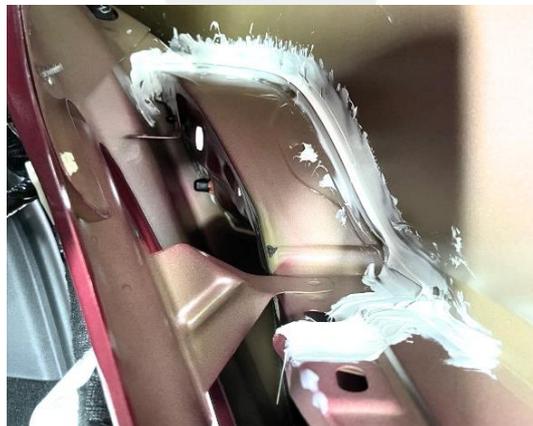
Figure 12

**NOTE:** Make sure to apply the sealant between the panels (Figure 12).

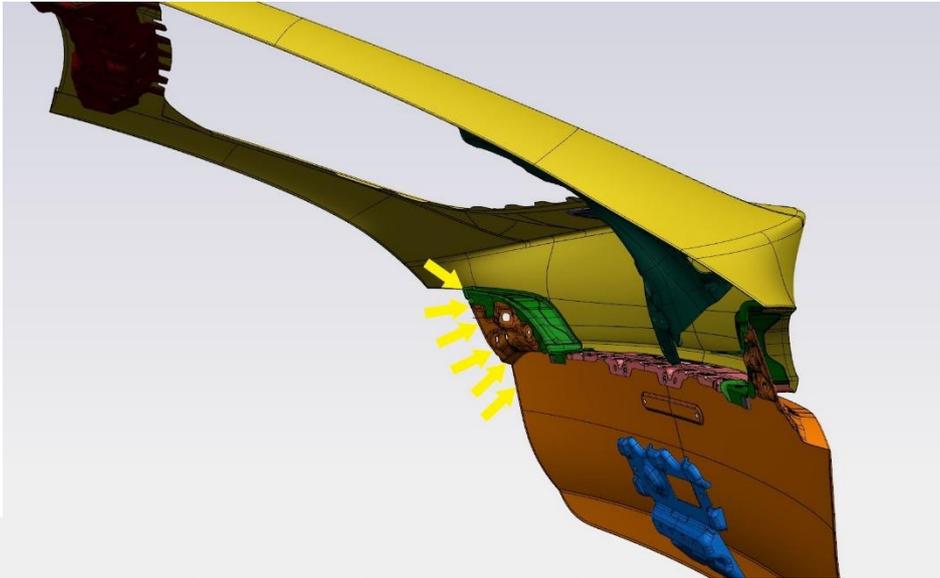
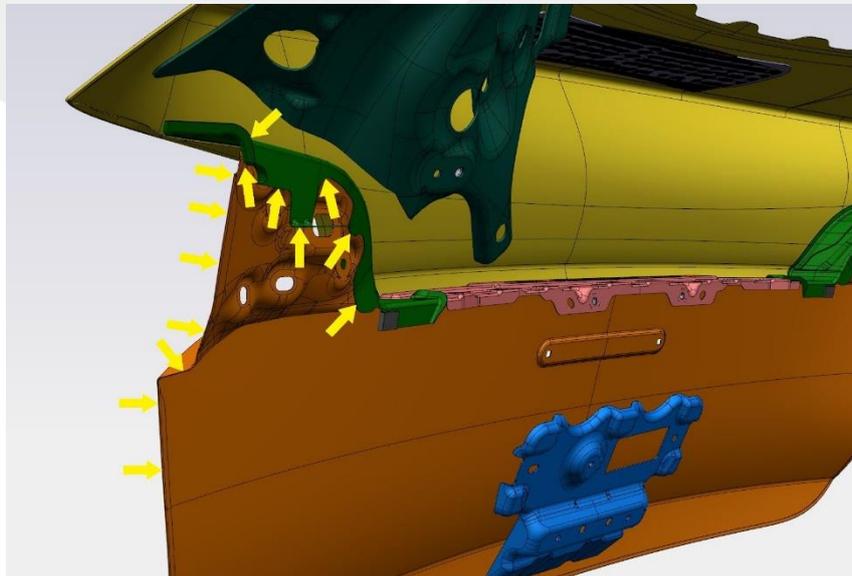
7. Apply the sealant on the sides and the back side of the LH and RH lamp can panels located inside the liftgate assembly (Figures 13–16). Spread the sealant bead with your finger while wearing a nitrile glove. Apply several sealant beads as needed.

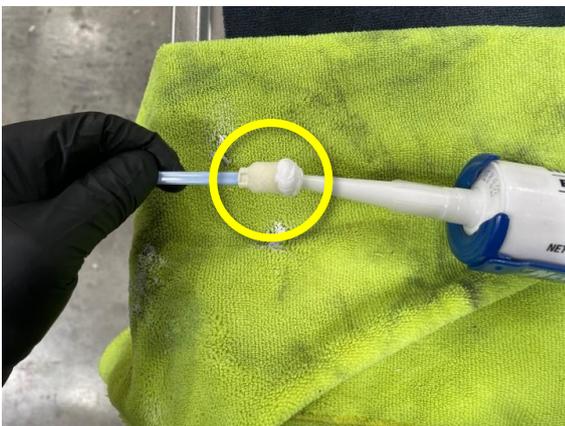
Figure 15

**NOTE:** Use the dauber (1939250-00-A) in tight spaces (Figure 15).

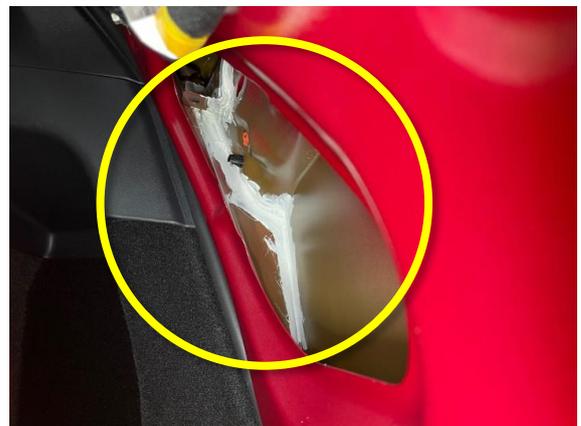
Figure 16

**NOTE:** Make sure to apply the sealant between the panels (Figure 16).

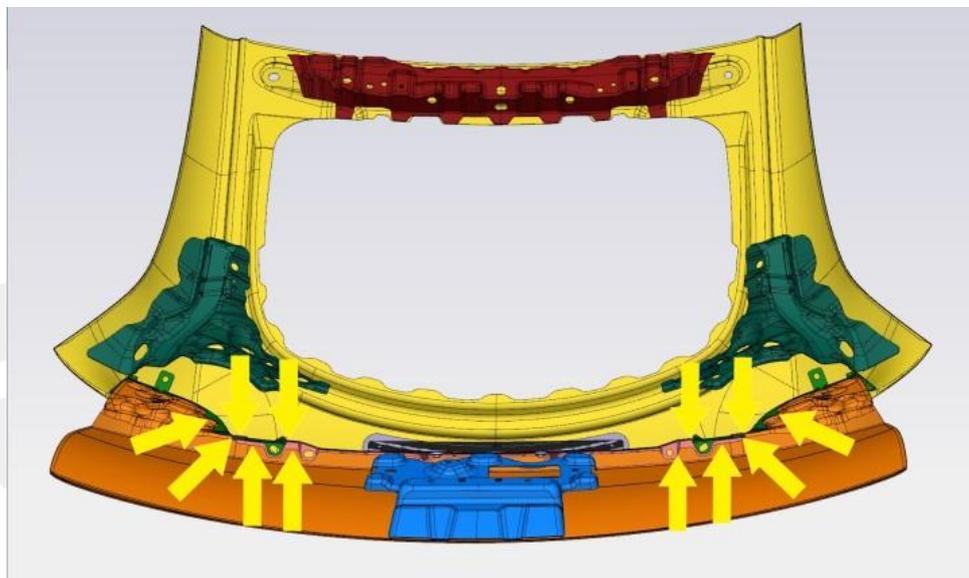
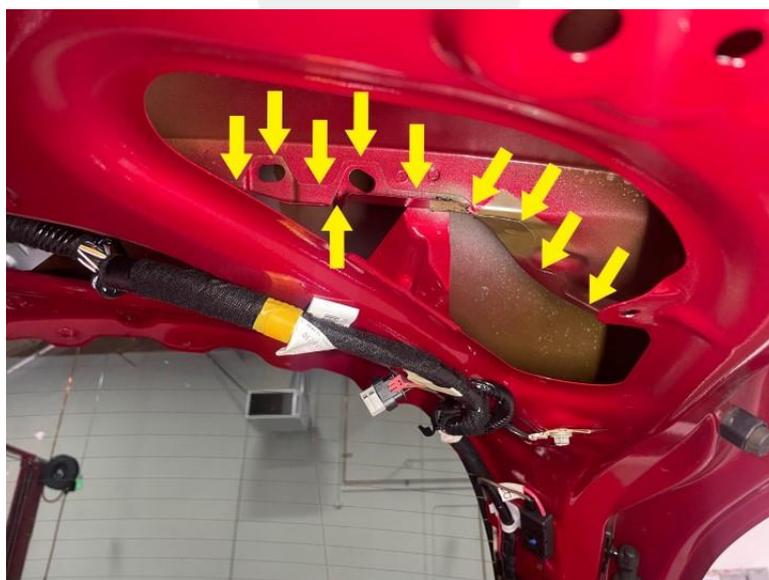
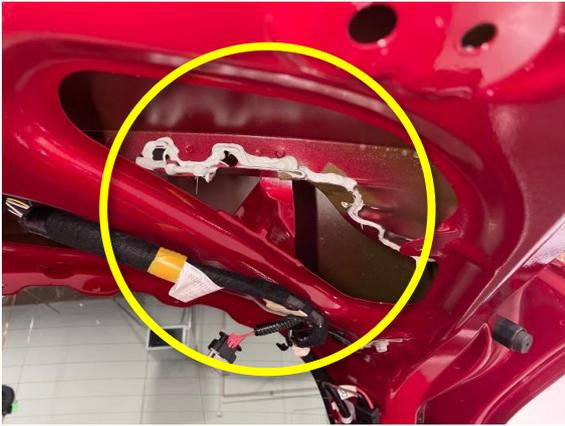
8. Apply the sealant on the bottom side of the LH and RH lamp can panels located inside the liftgate assembly (Figures 16–20). Apply several sealant beads as needed.

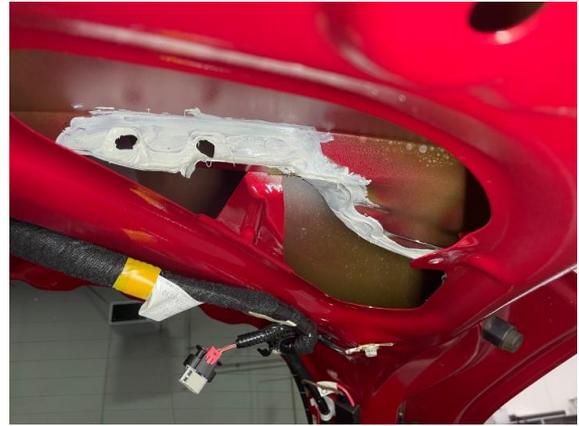
**Figure 20**

**NOTE:** Make sure to apply the sealant between the panels (Figure 20).

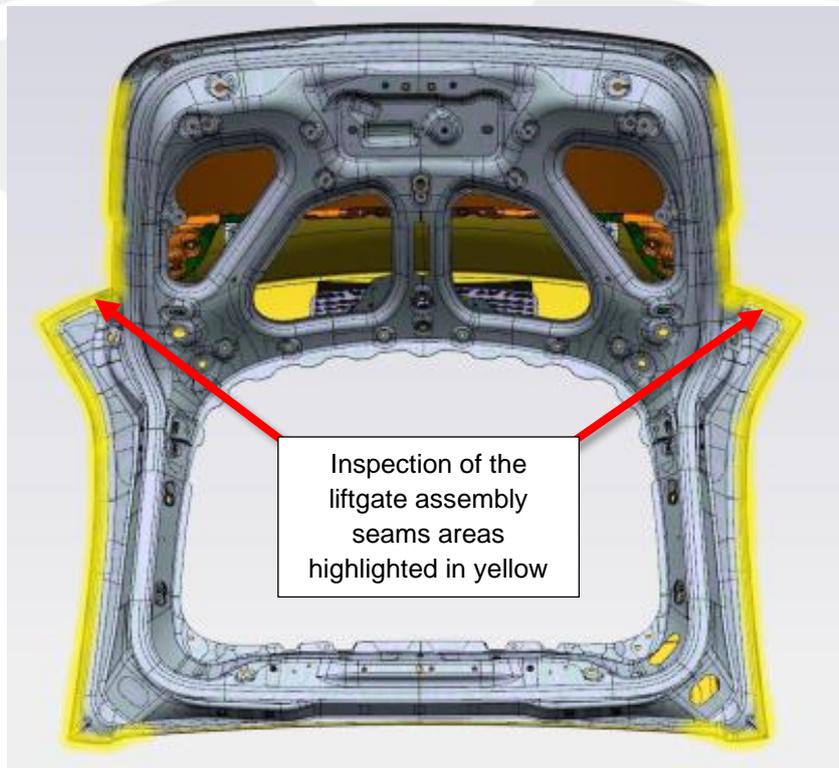
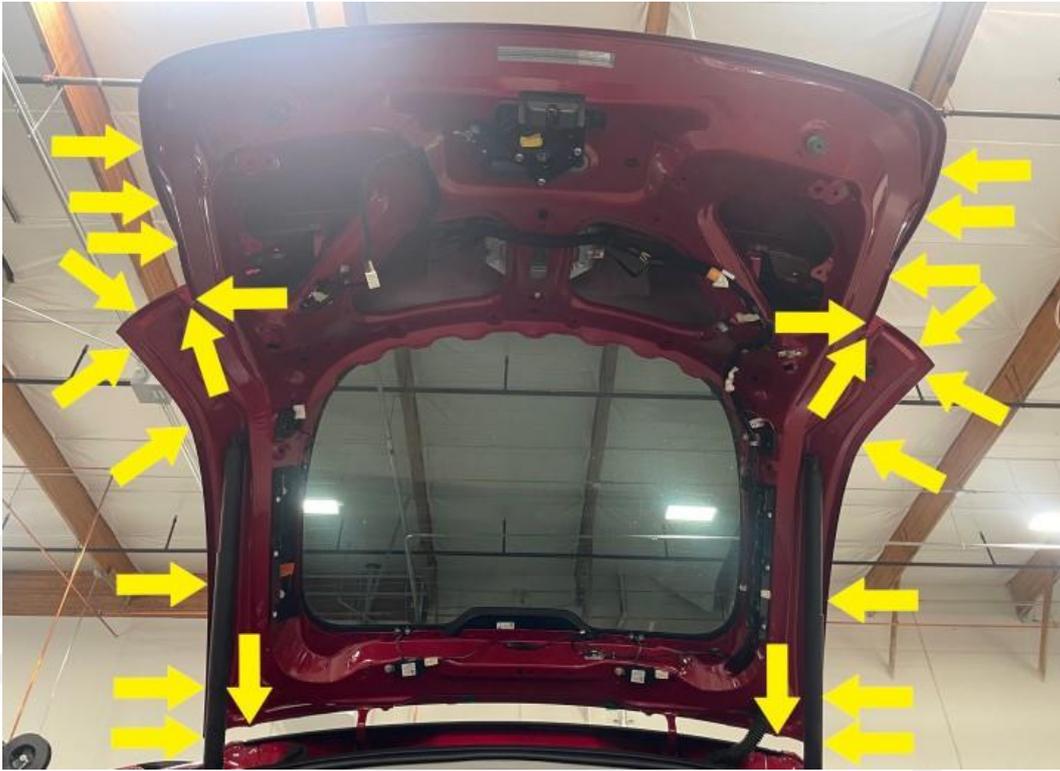
9. Inspect the liftgate assembly seams: Locate openings and pin holes in the highlighted areas (Figures 21–25).

11. Clean the liftgate assembly seams areas with Isopropyl Alcohol (IPA) wipes (Figures 21 and 22).
12. Apply sealant **ONLY** on the openings and pin holes found during the inspection (Figures 30 and 31).

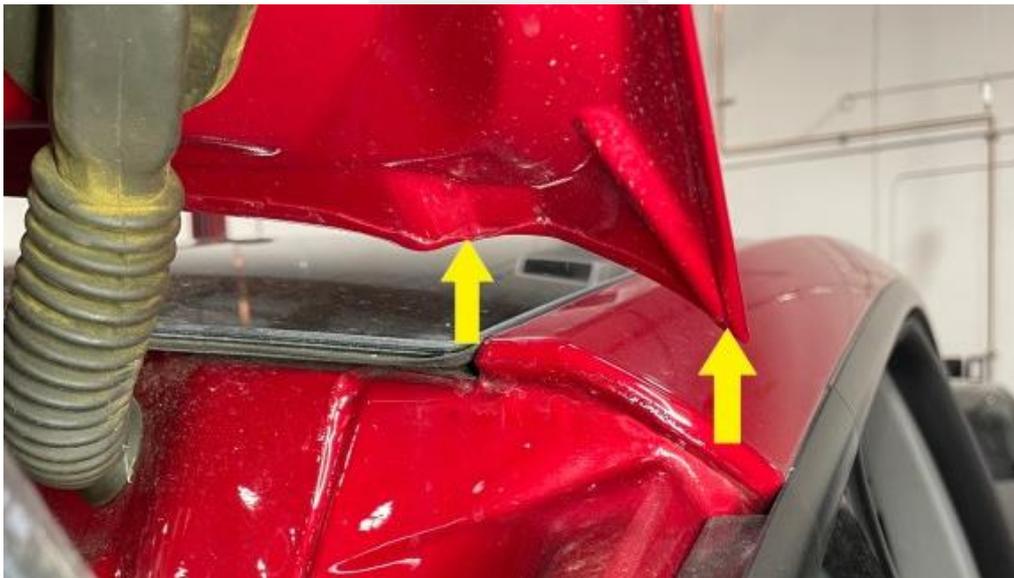
Figure 23 – Example of liftgate assembly seam

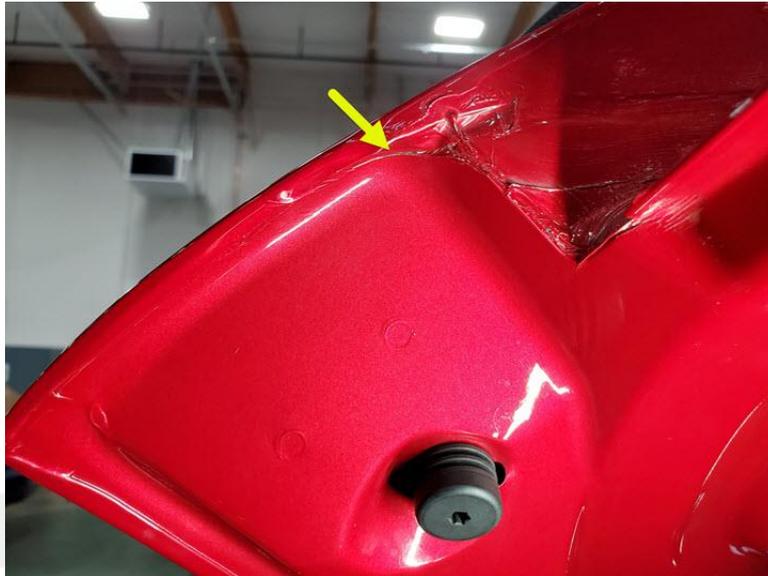
**Figure 24 – Example of liftgate assembly seam**

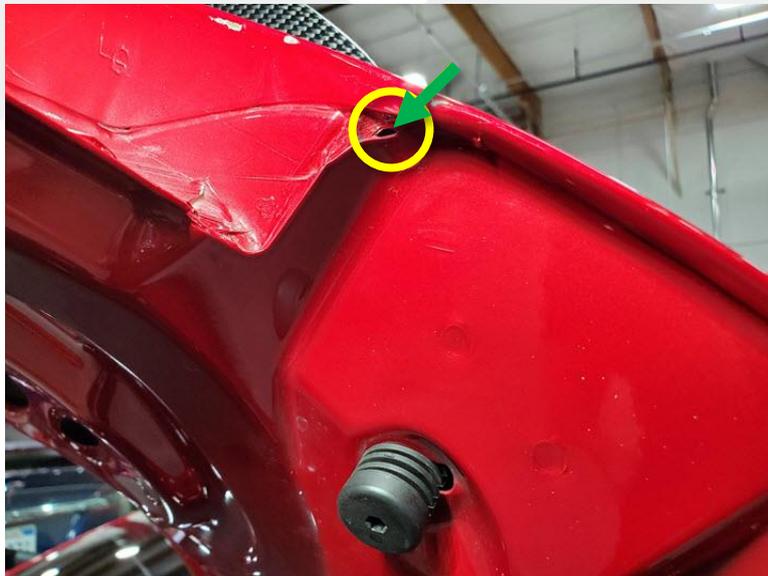
**Figure 25 – Example of pin hole on the liftgate assembly**

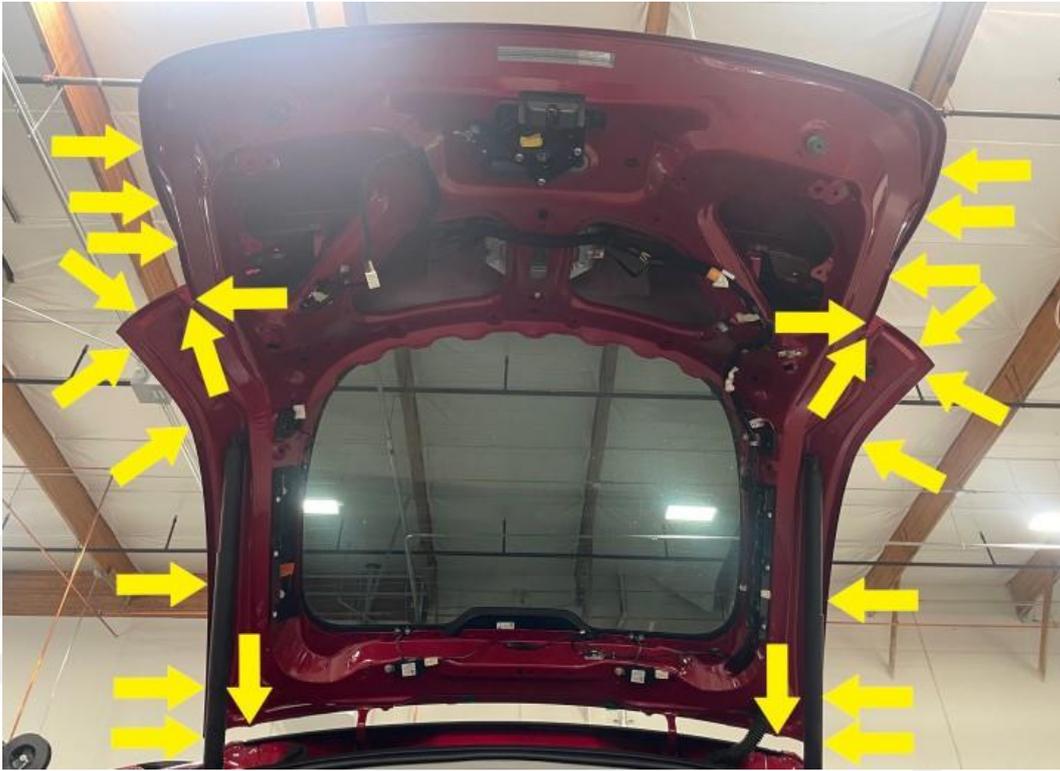
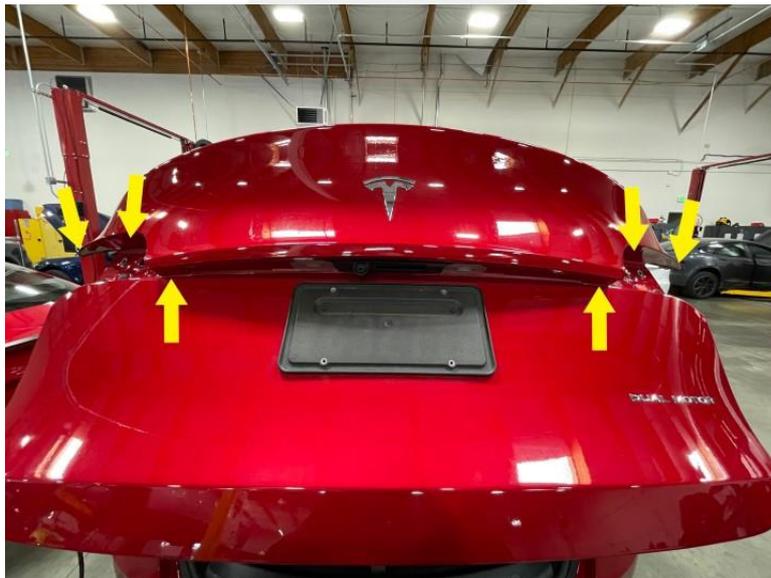
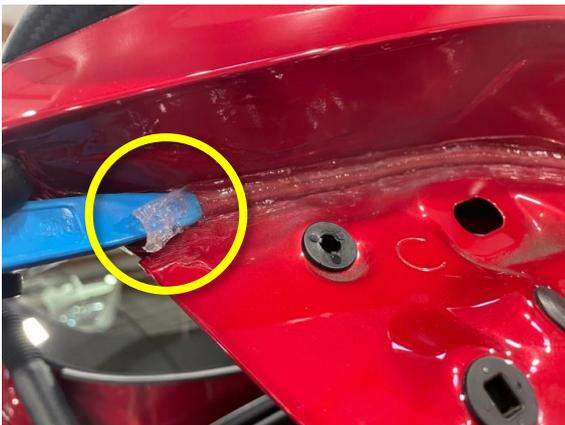
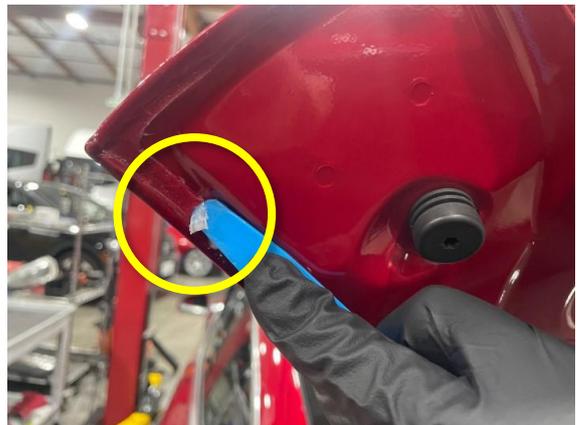
10. Use a plastic trim tool to remove any previously applied **non-factory** sealants in the highlighted areas, if present (Figures 26–29).

**⚠ CAUTION:** Do **NOT** remove factory sealant. To differentiate between factory sealant and non-factory sealant, factory sealant is painted over and is harder to remove, and non-factory sealant is usually clear and easier to remove than factory sealant.

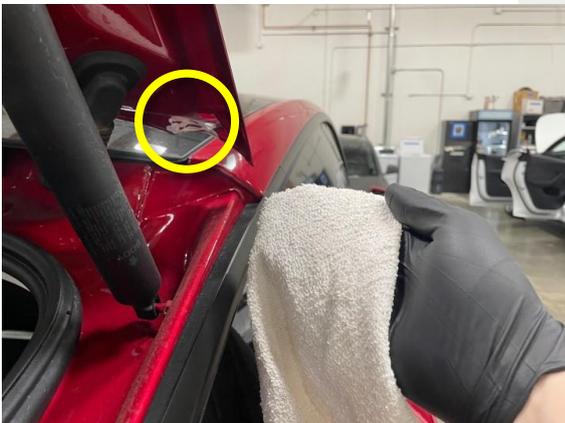
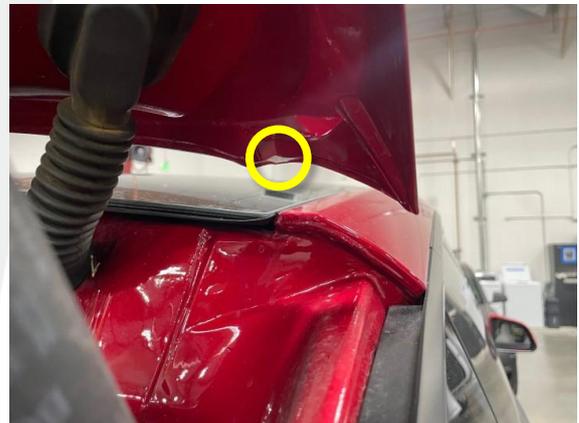
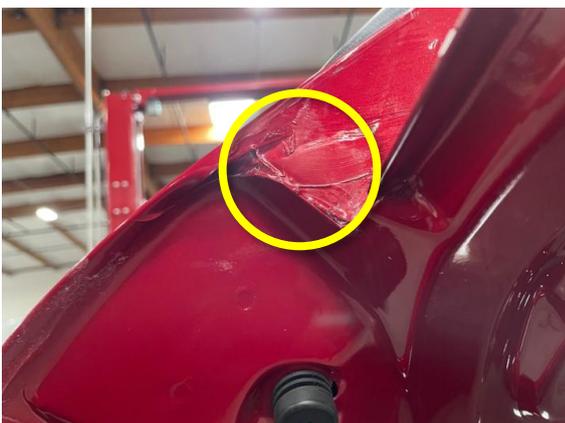
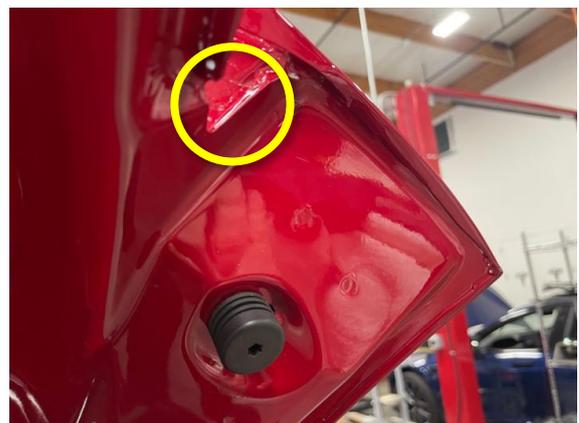
13. Remove excess sealant with a clean, dry microfiber cloth. Allow 1 hour for the sealant to fully cure (Figures 32–35).

**⚠ CAUTION:** Do not use chemicals to remove excess sealant.

**📄 NOTE:** The sealant must be allowed to cure for 1 hour because touch-up paint will be applied onto it later in this procedure.

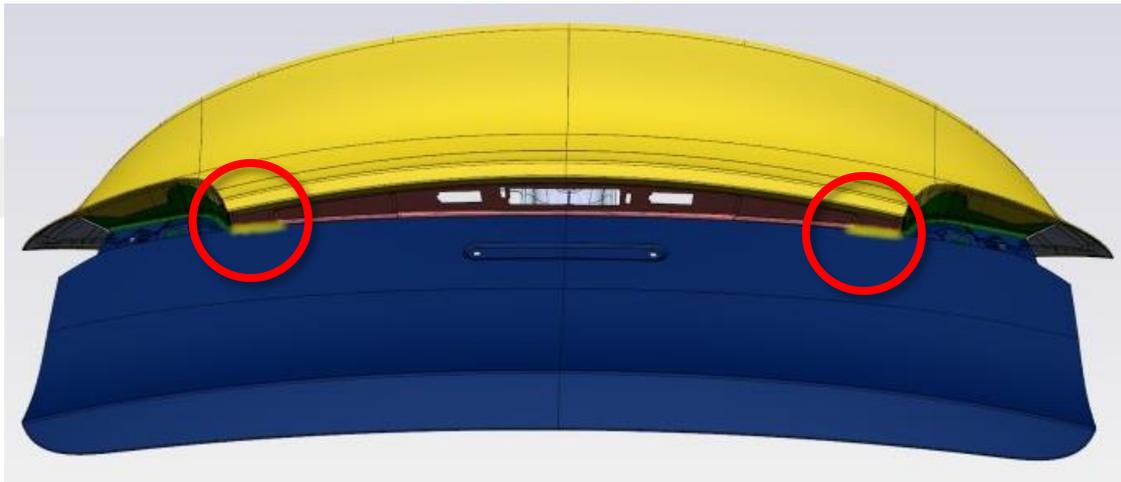
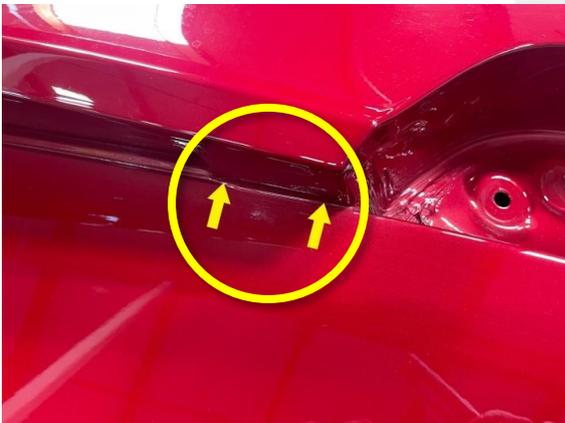
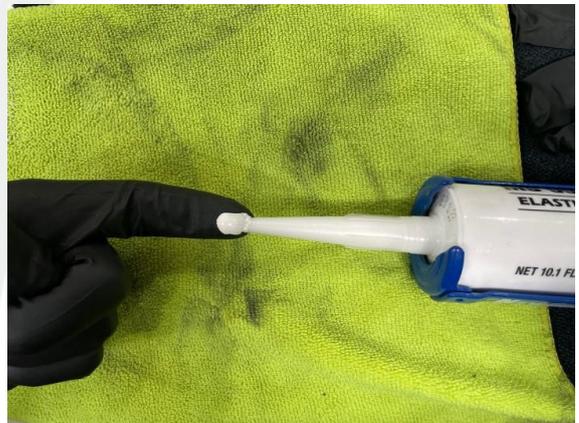
14. Apply sealant on the upper and lower panel mating surfaces for the LH and RH sides (Figures 36–39). Allow 1 hour for the sealant to fully cure.

**NOTE:** Apply sealant with your finger while wearing a nitrile glove, and then work sealant onto the factory sealant.

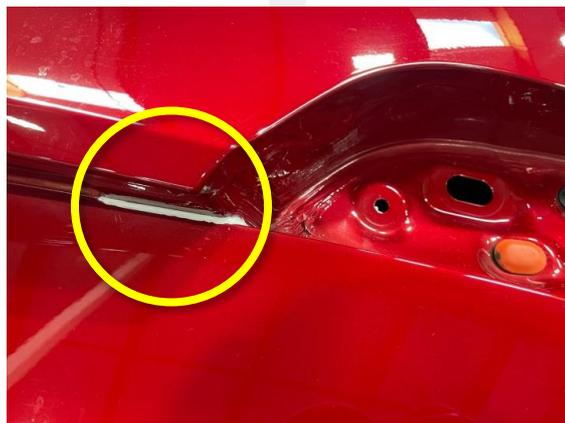
**NOTE:** Make sure to apply the sealant between the panel mating surfaces (Figure 39).

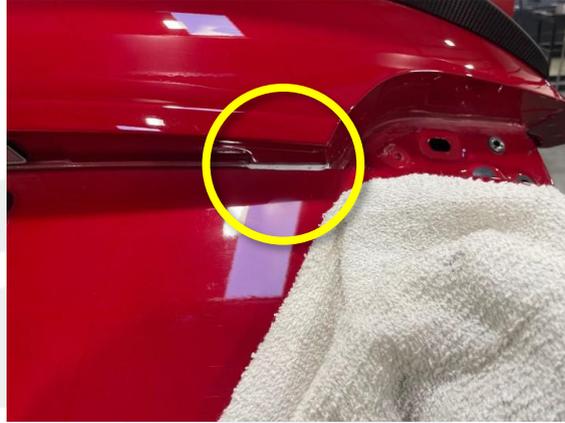
**Figure 40**

15. Remove excess sealant from the upper and lower panel mating surfaces with a clean, dry microfiber cloth (Figure 40). Allow 1 hour for the sealant to fully cure.

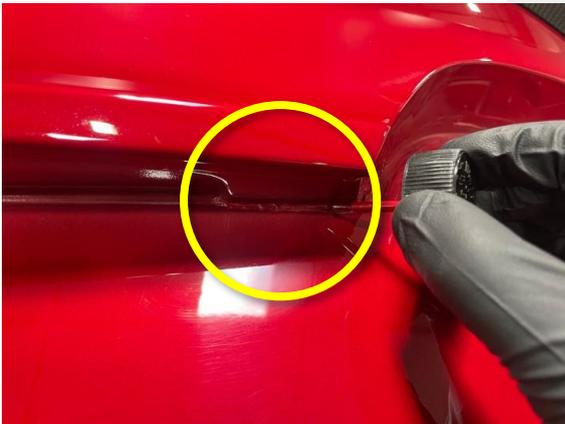
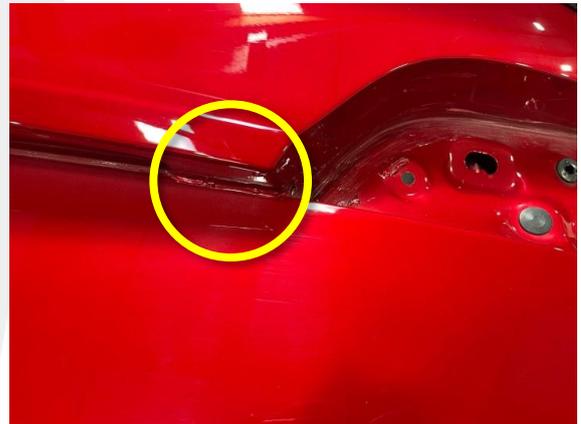
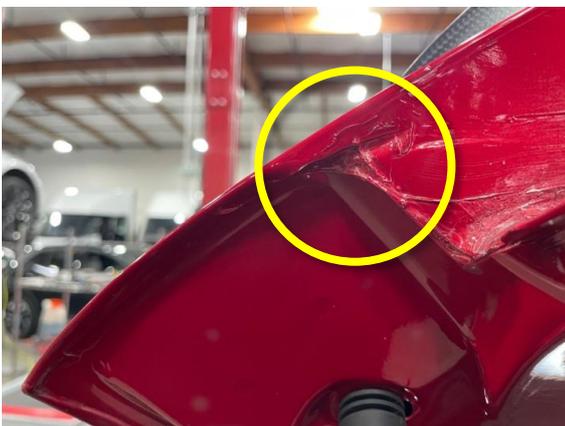
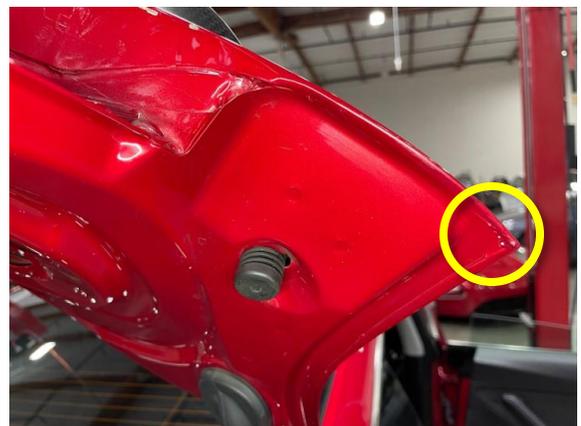
16. Apply touch-up paint onto newly sealed areas (Figure 41–44).

**📄 NOTE:** Make sure sealant is dry to the touch before touch-up paint is applied.

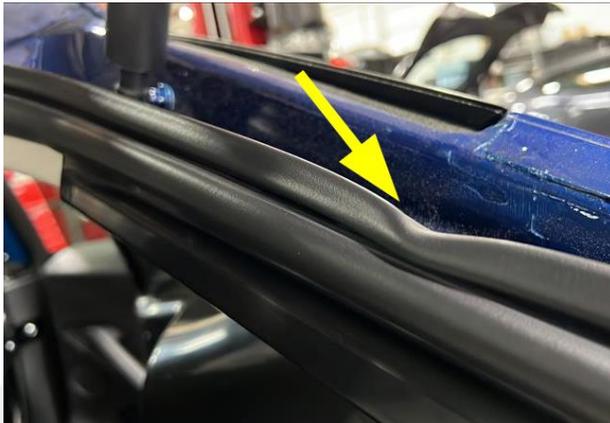
**✗ Figure 45**

17. Inspect the overall condition of the liftgate seal. If the liftgate seal is compromised (Figure 45), replace the seal (refer to Service Manual procedure [11702002](#)).

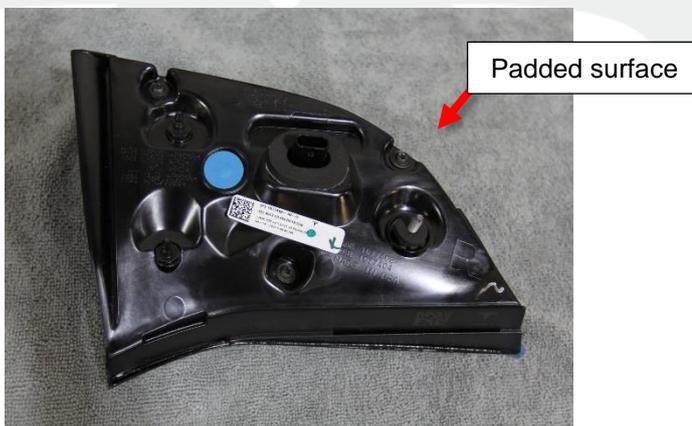
**Figure 46**

18. Put the RH rear fog/reverse light upside down on a padded surface (Figure 46).

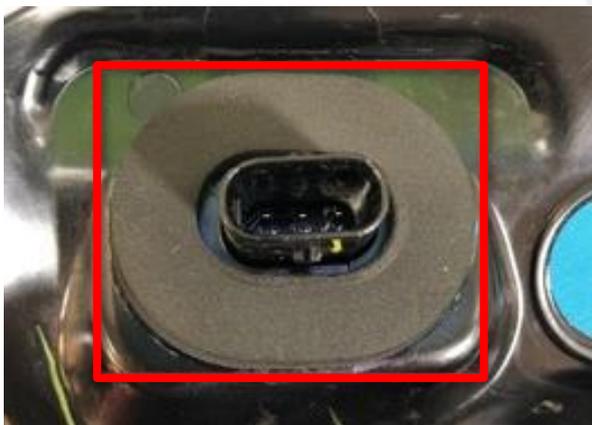
**Figure 47**

19. Remove and discard the gaskets for the RH light connector (Figure 47) and mounting stud (Figure 48), and then replace them with new ones (Figures 49 and 50).
