Trim - B-Pillar - Upper - LH (Remove and Install)

Correction Code 15184201

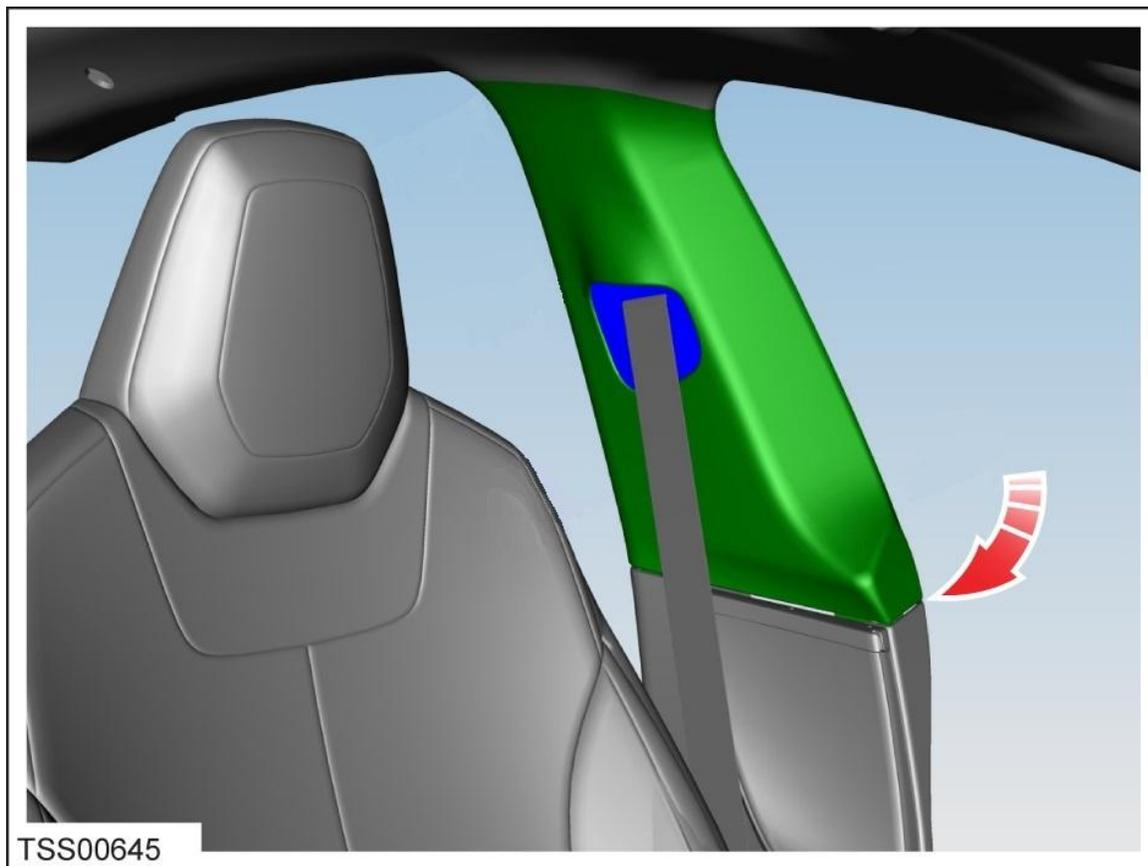
1. Remove the LH lower B-pillar trim ([refer to procedure](#)).
2. Carefully release the clips that secure the B-pillar upper trim to the body. Gently pull the lower edge away from the body and release the locator posts from the headliner.

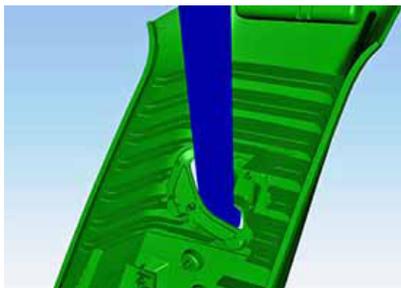
3. Allow the B-pillar upper trim to rest on the seatbelt buckle.
