USB Hub - Center Console - Front (Remove and Replace)

Correction code 21260402

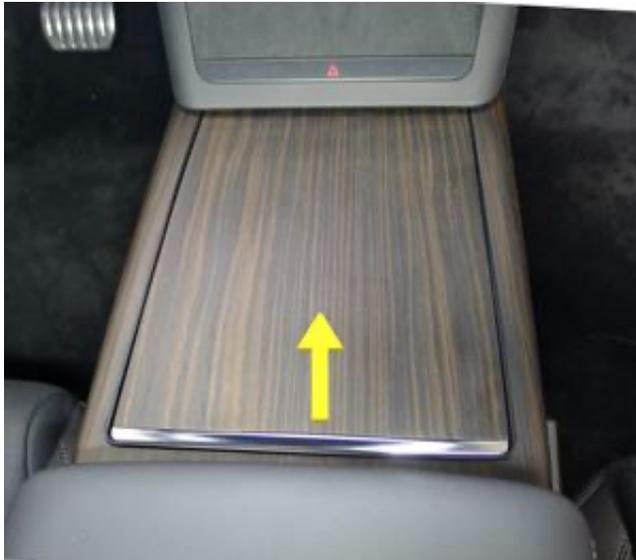
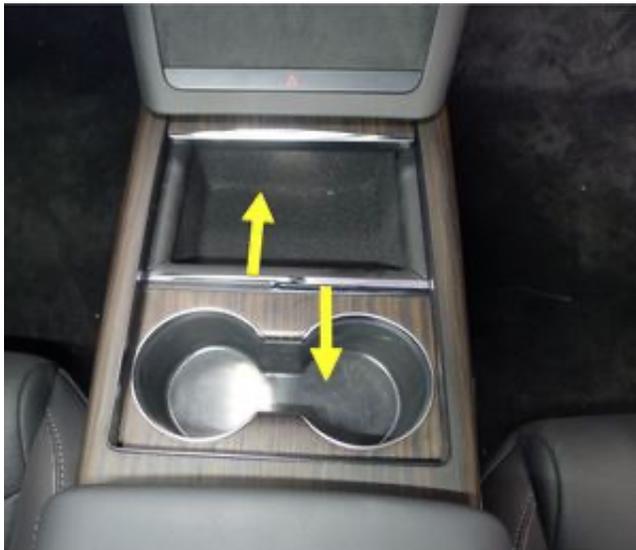
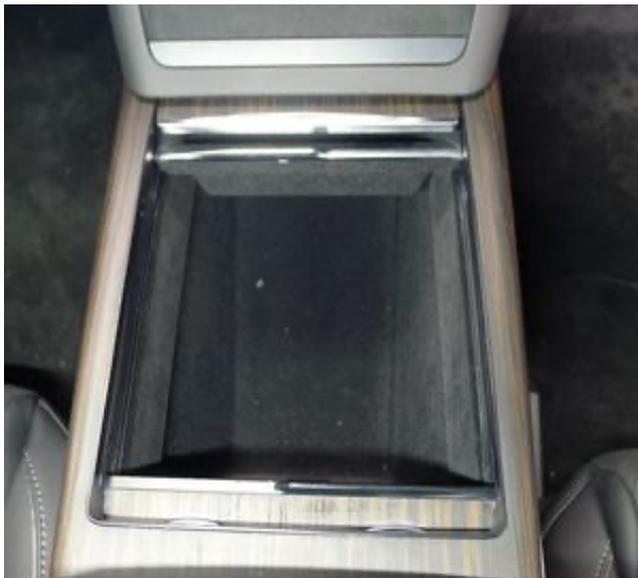
1. Open the RH front door and lower the RH front window.
2. Move the front passenger seat rearward.
3. Fully retract the center console lid, cupholder and sliding tray into the locked position.

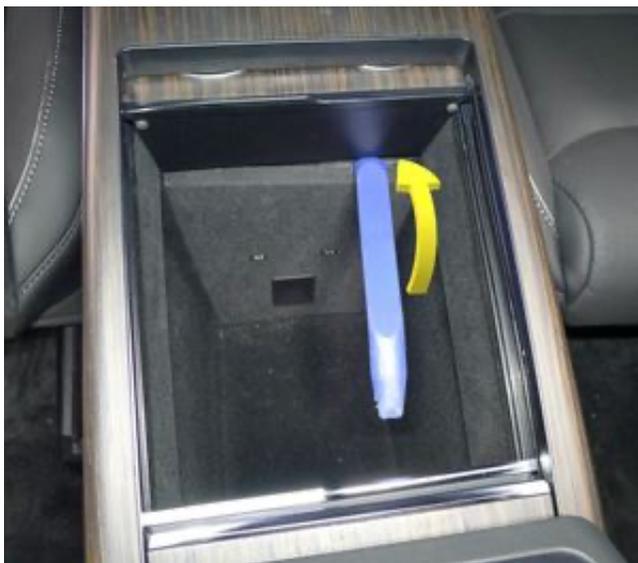
4. Use a 90 degree plastic trim tool to release the clips (x4) that attach the center console service panel to the center console, and then pull the panel upward to access the harness.

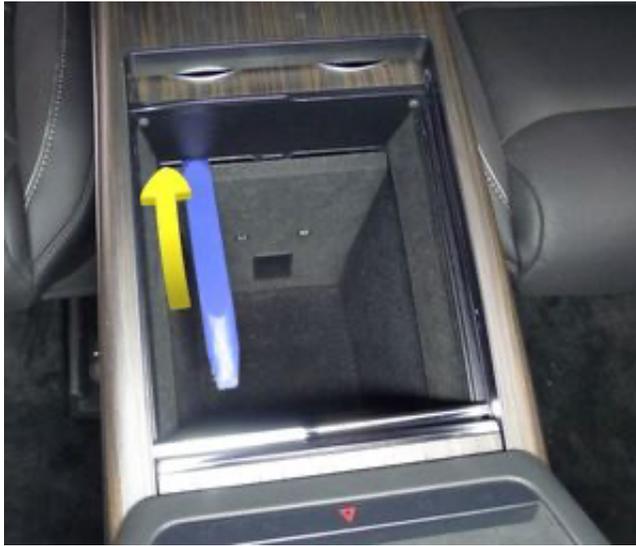
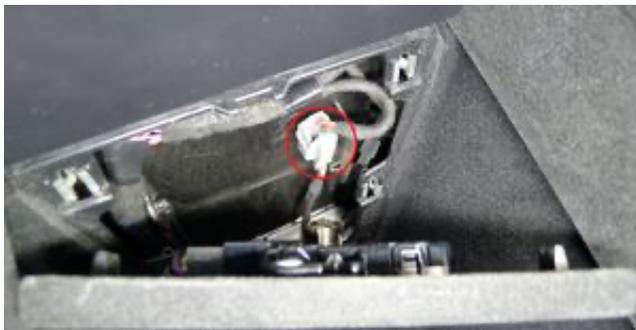
5. Disconnect the center console service panel electrical connectors (x3), and then remove the assembly from the center console.

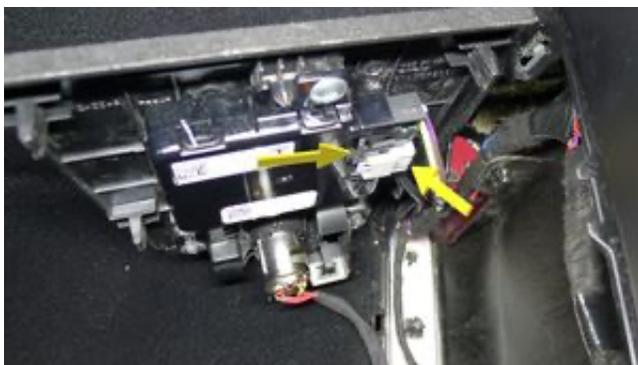
6. Remove the screws (x3) that attach the front USB hub to the service panel assembly.

1.5 Nm (1.1 lbs-ft)

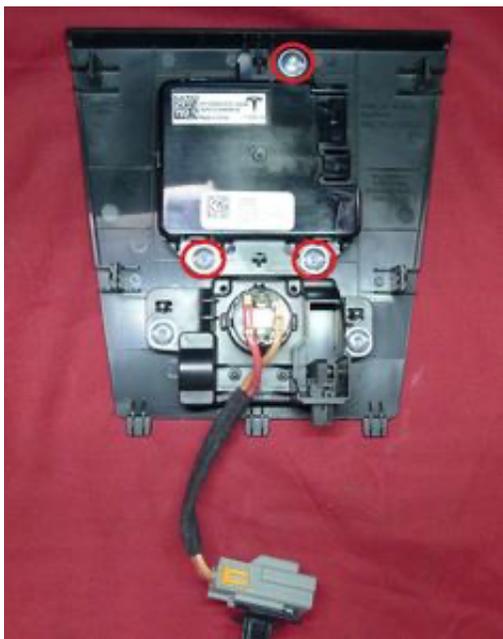
1. Position the front USB hub onto the service panel assembly, and then install the screws (x3) that attach the hub to the assembly.

1.5 Nm (1.1 lbs-ft)

Use the alignment tabs to ensure the USB hub is correctly positioned.

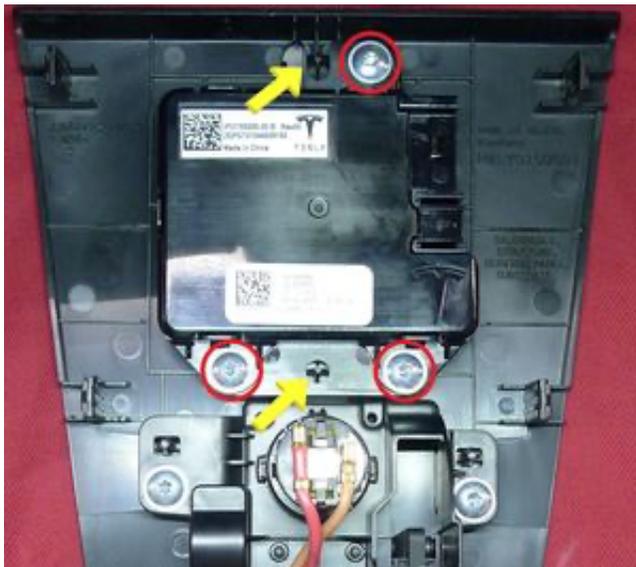
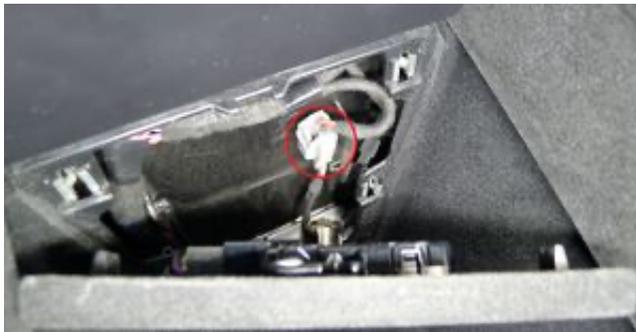
2. Position the center console service panel assembly into the center console, and then connect the electrical connectors (x3).
