TN-22-16-001 June 8, 2022

Tesla, Inc. Technical Note
Model:	Vehicle System:	Region:
Model Y Structural Pack	16 - Battery System	All

Inspect the Model Y Structural HV Battery for Underside Damage

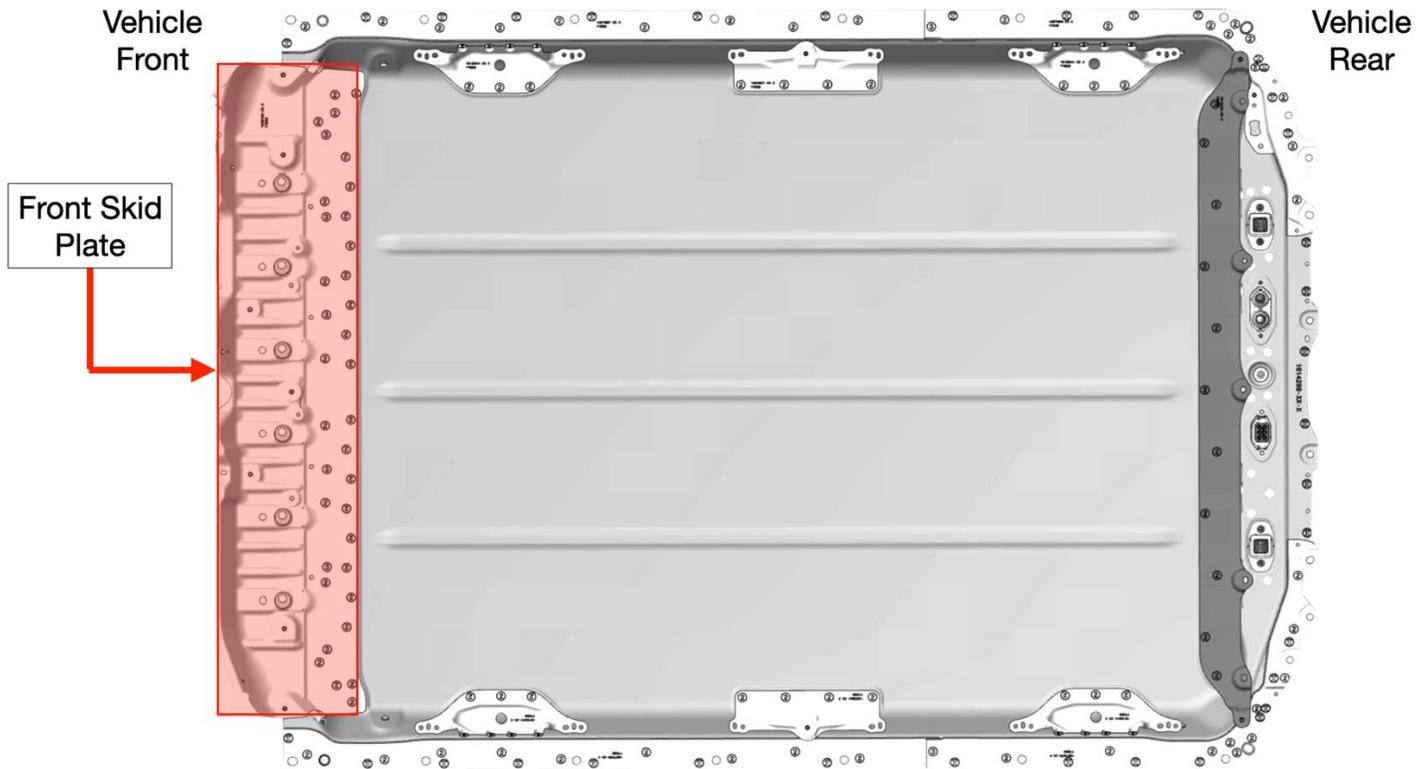
Figure 9 – Front skid plate location

1. Remove the front aero shield (refer to Service Manual procedure [12030112](#)).
2. Visually inspect the front skid plate for tears, dents, or breaches.
3. Inspect the HV cables, coolant hoses, baseplate, and passthroughs above the front skid plate.
4. If there is damage to the front of the enclosure above the front skid plate, see “[Front Zone](#)” section below.
5. If there is damage that extends onto the array baseplate, array barrier, or side zone, go to those specific sections below.

NOTE: The bolts that join the front aero shield and front skid plate are prone to shearing in the event of front skid plate damage.

- Deburr the area with a hand deburring tool to remove the sharp edges if sharp edges are found.
- Re-tap the fastener hole if a fastener hole is damaged and the fastener cannot withstand full torque.
- Recommend replacement of the:
 - Fastener if the fastener is damaged or stripped.
 - HV cables if the HV cables are damaged above the front skid plate.
 - Coolant hose if the coolant hose is damaged.
 - Front aero shield if the aero shield is damaged or cannot be secured properly.
- Recommend HV battery replacement if:
 - The front skid plate, or part of the front skid plate, is bent beyond repair, detached, or not covering the baseplate.
 - If the coolant passthrough is damaged.
 - The HV battery enclosure fails leak test due to impact.
 - The HV battery enclosure has low isolation due to impact.

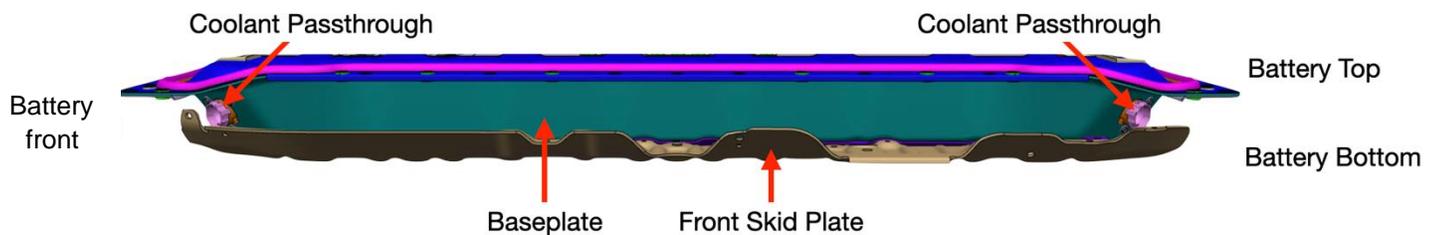
Figure 10 – Front zone

The front zone includes everything located at the front of the HV battery except the front skid plate (Figure 10).

- Deburr the area with a hand deburring tool to remove the sharp edges if sharp edges are found.
- Recommend replacement of the:
 - HV cables if the HV cables are damaged above the front skid plate.
 - Coolant hose if a coolant hose is damaged.
 - Front aero shield if the aero shield is damaged.
- Recommend HV battery replacement if:
 - A coolant passthrough is damaged.
 - The HV battery enclosure fails leak test due to impact.
 - The HV battery enclosure has low isolation due to impact.

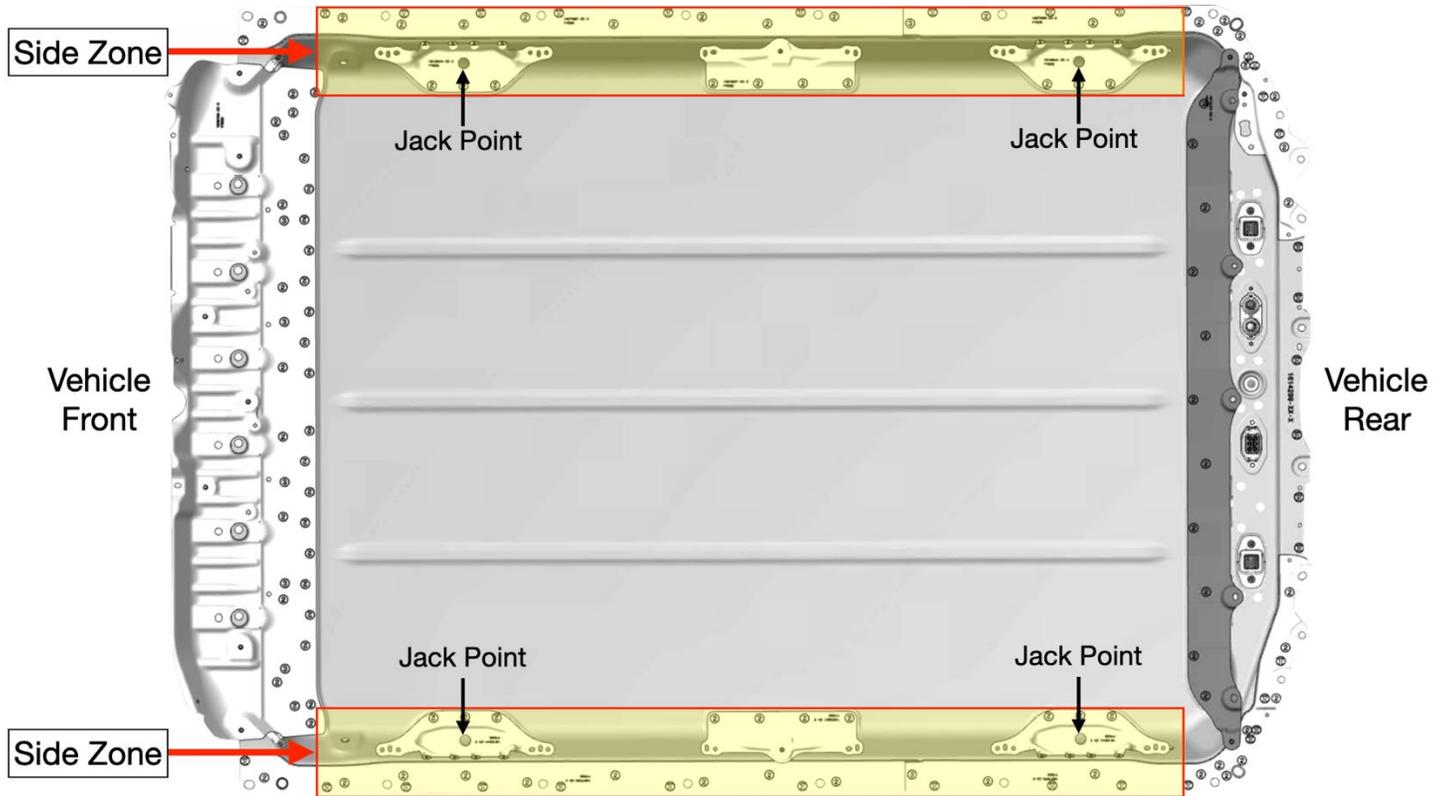
Figure 11 – Side zones

The HV battery has two side zones (Figure 11). For each side zone, there is a front and rear jack point, along with multiple rocker panel mounts which hold the rocker panels in place to protect the sides of the HV battery enclosure. The side zone includes both sides of the HV battery enclosure itself when the side rocker covers are removed.

- Deburr the area with a hand deburring tool to remove the sharp edges if sharp edges are found.
- Re-tap the fastener hole if a fastener hole is damaged and the fastener cannot withstand full torque.
- Recommend replacement of the:
 - Fastener if the fastener is damaged or stripped.
 - HV cables if the HV cables are damaged.
 - Coolant hose if the coolant hose is damaged.
 - Rocker cover if the rocker cover, or part of the cover is detached from the HV battery and cannot be secured properly.
- Recommend HV battery replacement if:
 - A jack point has extensive damage where it cannot be used to safely lift the vehicle.
 - The HV battery enclosure fails leak test due to impact.
 - The HV battery enclosure has low isolation due to impact.

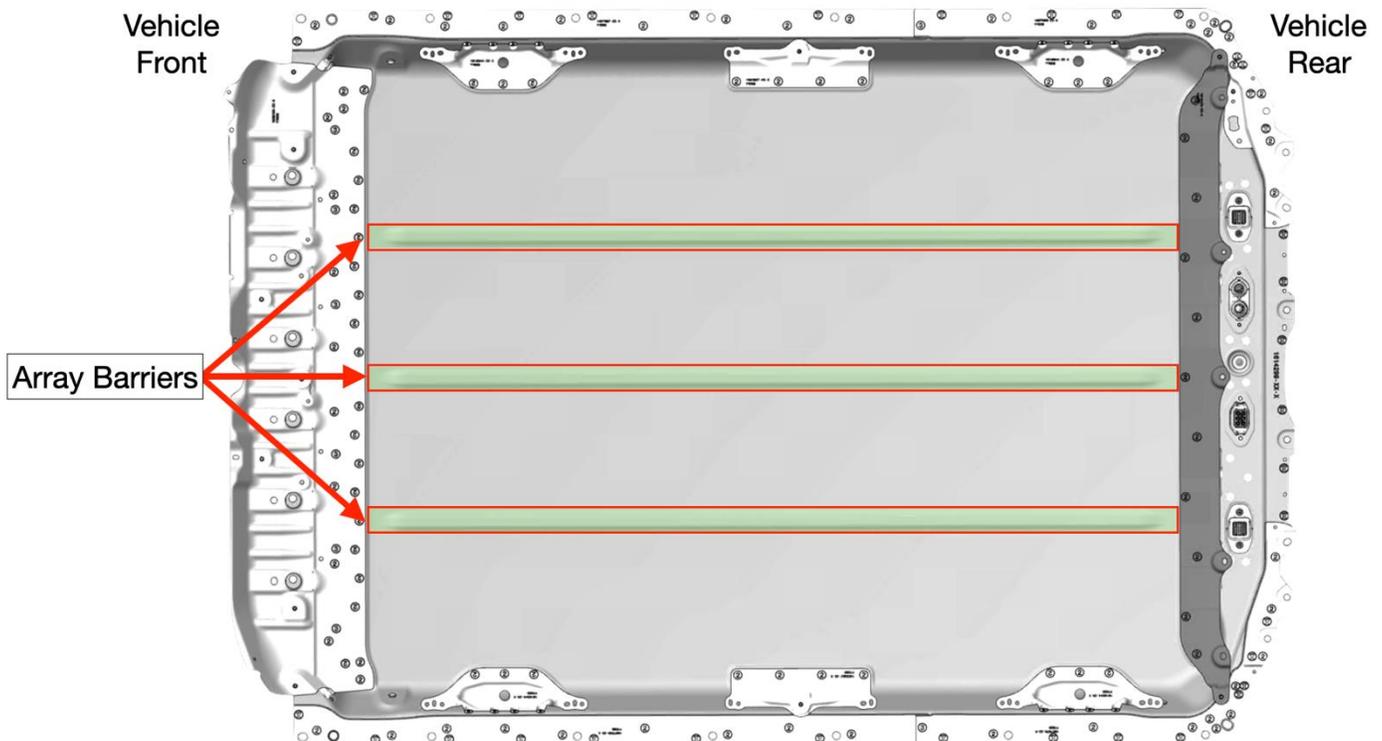
Figure 15 – Array barriers

The array barriers are located between the 4 battery arrays and act as a separator for each array (Figure 15). The array barriers start at the rear of the front skid plate and extend to the front edge of the rear aero shield bracket.

- Deburr the area with a hand deburring tool to remove the sharp edges if sharp edges are found.
- Recommend HV battery replacement if:
 - The HV battery enclosure fails leak test due to impact.
 - The HV battery enclosure has low isolation due to impact.

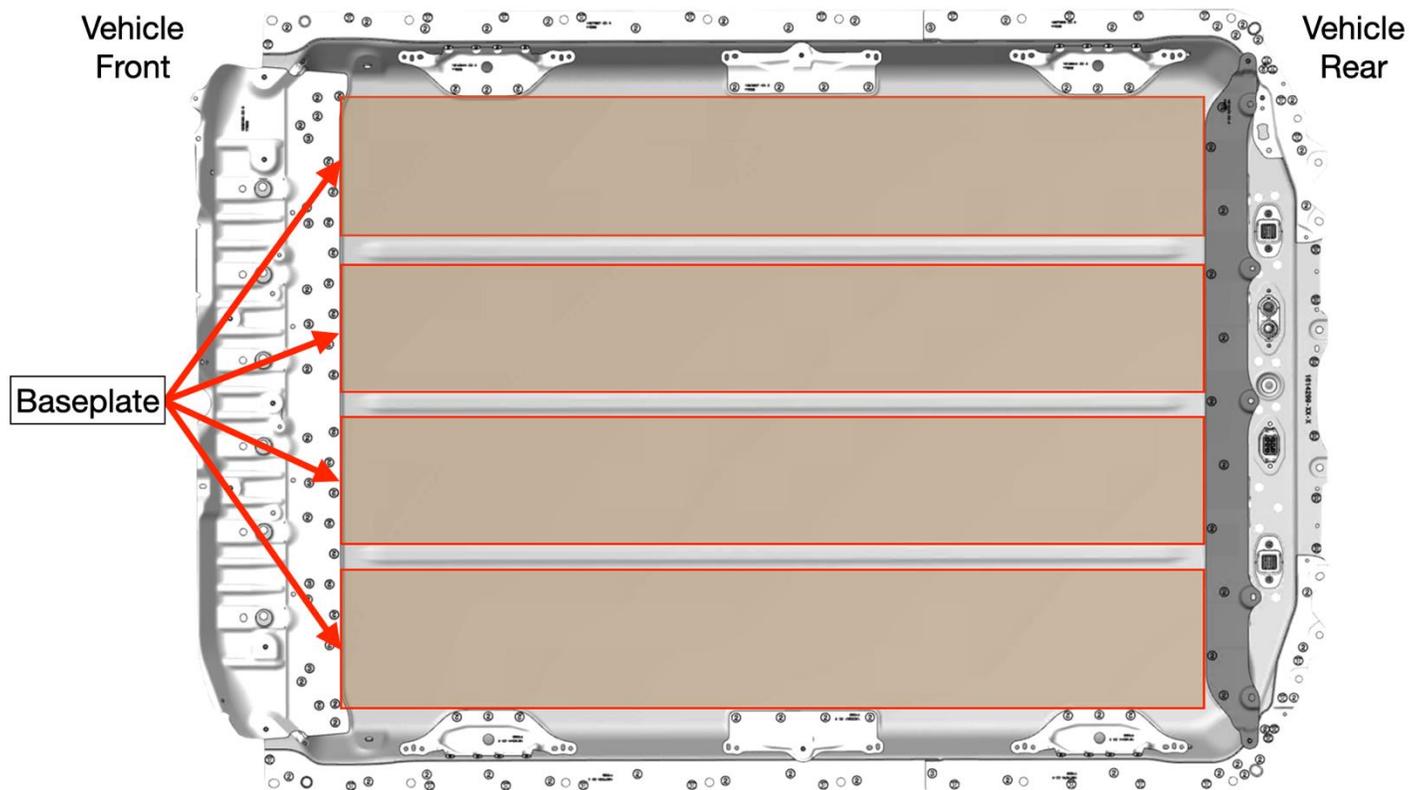
Figure 16 – Array baseplate

The array baseplate zones covers most of the underside of the HV battery and serves as a base for the battery arrays (Figure 16). The array baseplate zones start at rear of the front skid plate and extends to the front edge of the rear aero shield bracket.

When the baseplate is damaged, follow the steps below:

- Deburr the area with a hand deburring tool to remove the sharp edges if sharp edges are found.
- Recommend HV battery replacement if:
 - A dent or deepest point of gouge is **5 mm** or more in depth (Figures 17 and 18) within the array baseplate zone.

- The HV battery enclosure fails leak test due to impact.
- The HV battery enclosure has low isolation due to impact.

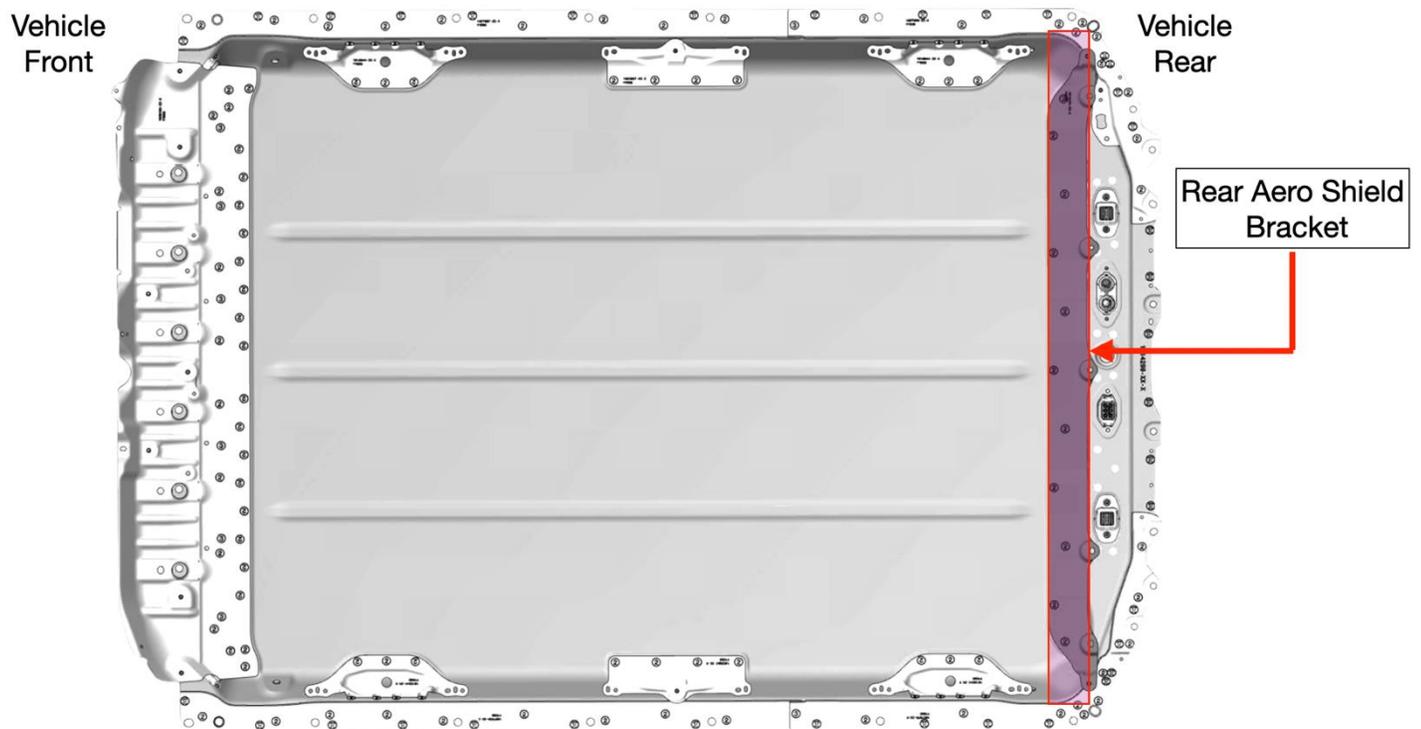
Figure 19 – Rear aero shield bracket

1. Remove the mid aero shield (refer to Service Manual procedure [12030502](#)).
2. Remove and assess damage to components at the rear of the HV battery such as HV harness cables, passthroughs, baseplate, fasteners, etc. If any components at the rear of the HV battery are damaged or missing, see "[Connector / Rear Zone](#)" section below.

- Deburr the area with a hand deburring tool to remove the sharp edges if sharp edges are found.
- Recommend replacement of the:
 - Fastener if the fastener attaching the mid aero shield and rear aero shield bracket is damaged or stripped.
 - Mid aero shield if the aero shield is damaged or cannot be secured properly.
- Recommend HV battery replacement if:
 - The rear aero shield bracket, or part of the bracket, is bent beyond repair, detached, or not covering the baseplate.
 - The HV battery enclosure fails leak test due to impact.
 - The HV battery enclosure has low isolation due to impact.
