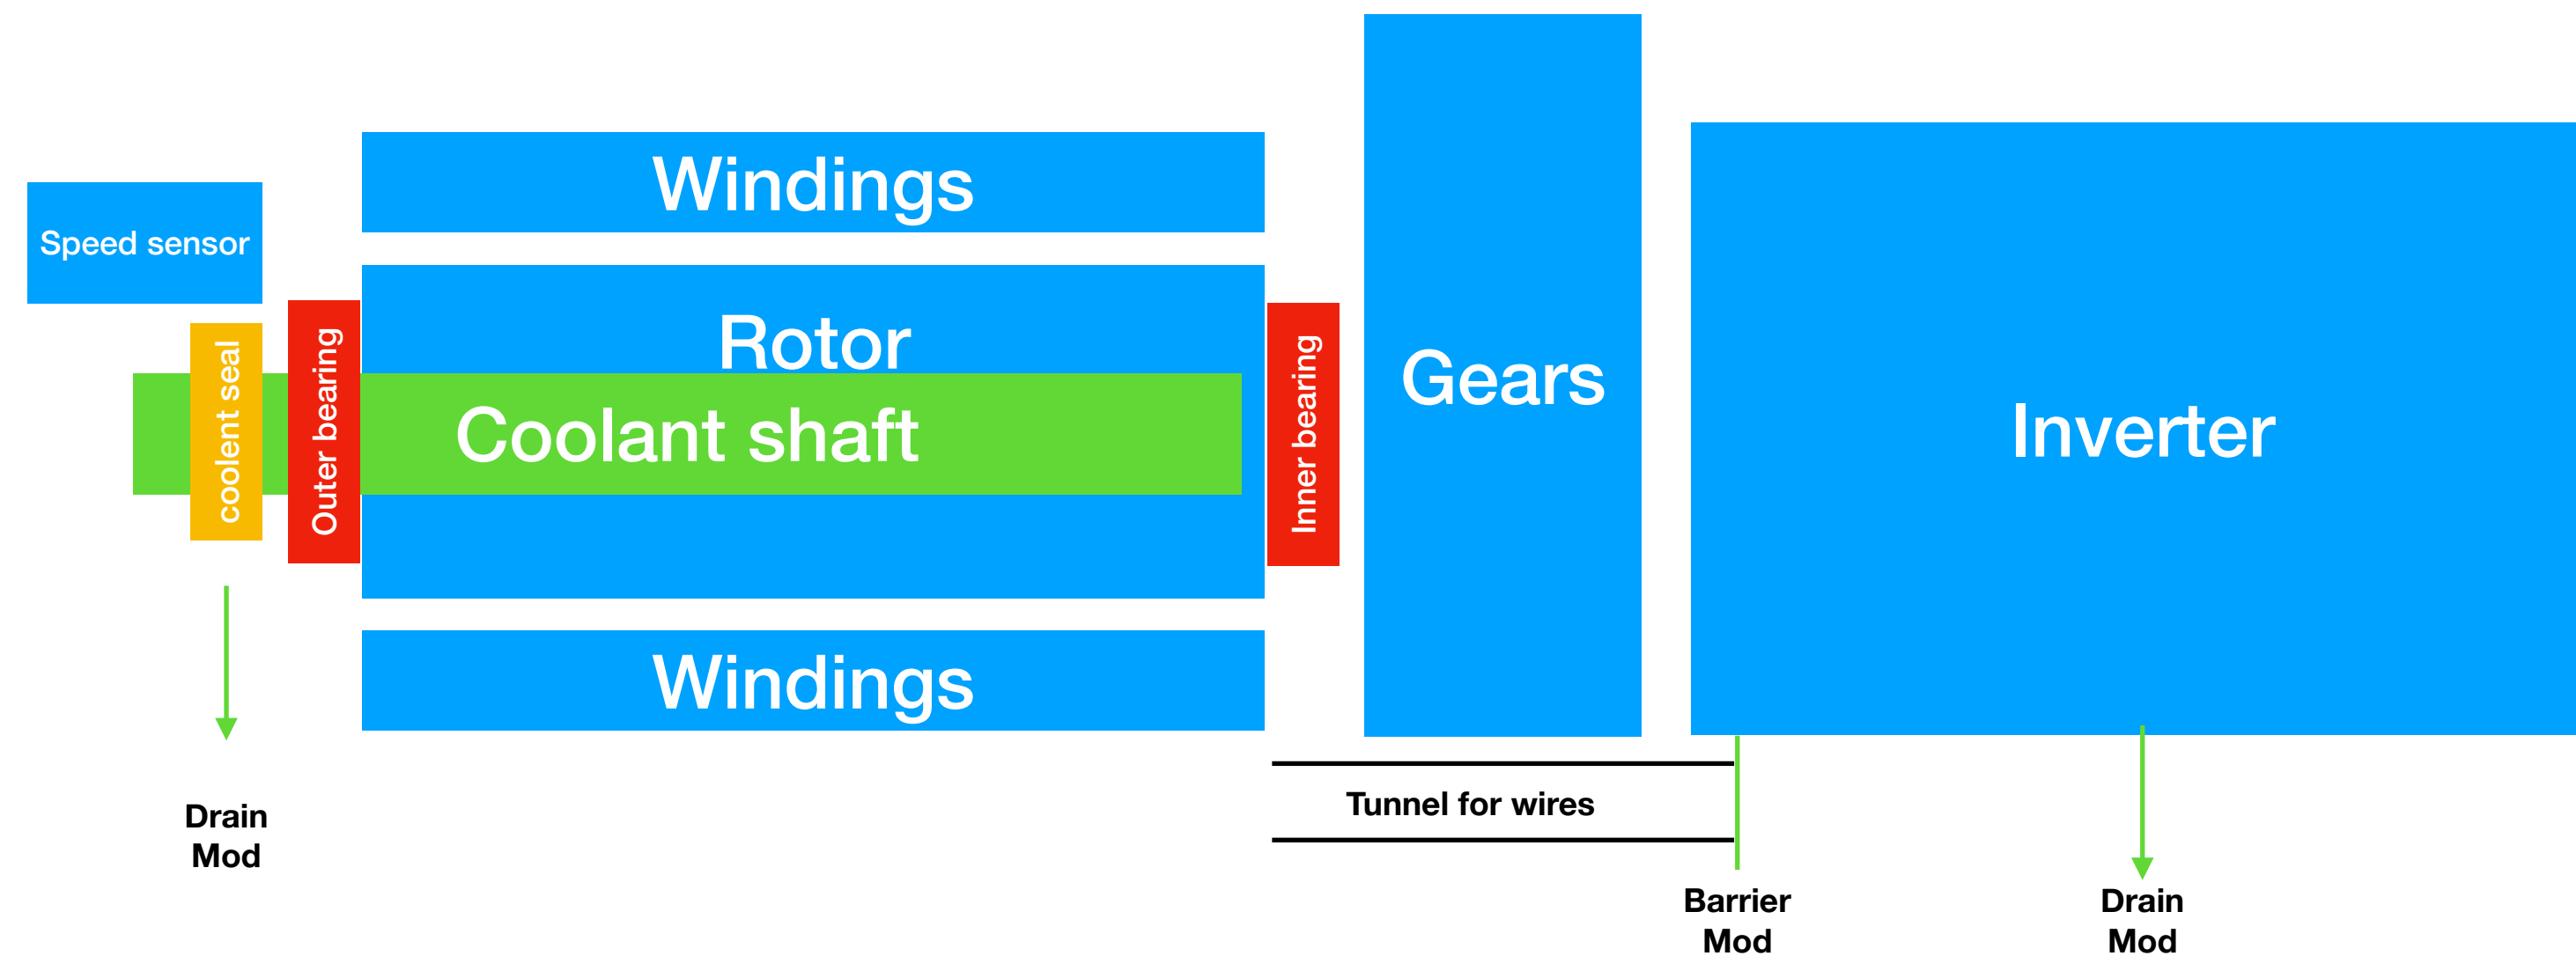
Coolant goes to the center of the rotor through a shaft to cool it.

Rotor spins at ~10k RPM @ 100mph

Need seal to keep coolant contained and not leak into motor's (rotor+windings) chamber

Seal leak quickly trashes outer bearing (nearby), then eventually inner bearing. Eventually goes through a tunnel (inverter's wire to the windings to generate magnetic field to rotate the rotor) to the inverter side where high voltage and current electronics components are.

Speed sensor is near the seal so a good part to inspect for leak. Leaked coolant likely gets spun all over any open chamber in this area resulting in the droplets we see on the sensor.

Seal failure mod. 2 drains, and a barrier. Keep leaked coolant out of motor chamber and inverter. Don't bet on seal won't leak in this particular design regardless how good the seal is. Seal is trying to keep out a very low viscosity (thin) water based coolant rather than something much thicker like oil.
